## St Helens Borough Section 19 Report: Billinge

Section 19 Flood Investigation Report of Incident on 8<sup>th</sup> December 2021

Report Reference LLFA/S19/2021/01

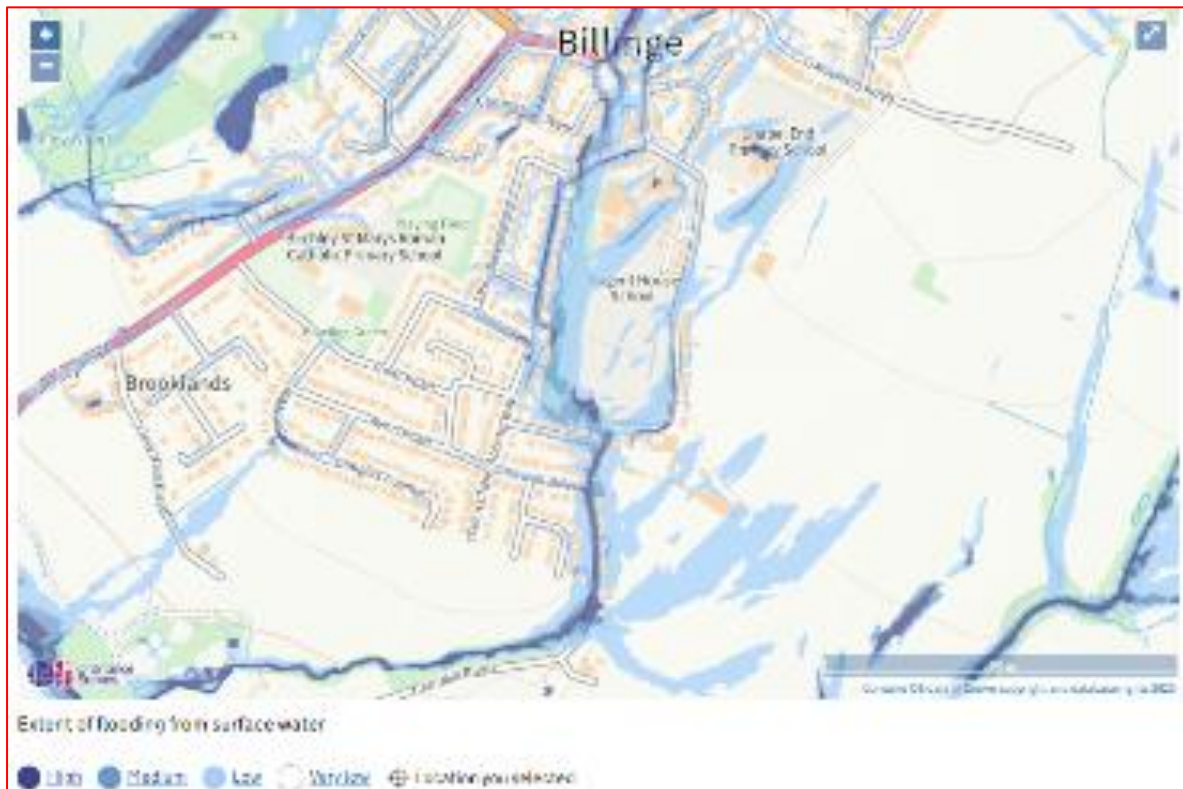
The EA surface water flood risk map (see *Figure 3*) shows that Brownheath Avenue, the area to its rear and, Powell Drive may be affected by surface water flooding. The level of risk does differ across the area, with the area to the rear of the properties and the eastern side of the two effected streets, having the highest risk. The risk of flooding indicated in the EA surface water mapping is indicative of low-lying areas or localised depressions in topography. The risk on both streets appears to vary between low and medium risk. The map also shows that surface water flooding has the potential to travel in between the properties, even within the low-risk category.

*Figure 3: EA's Surface Water Flood Map – Billinge, St Helens*

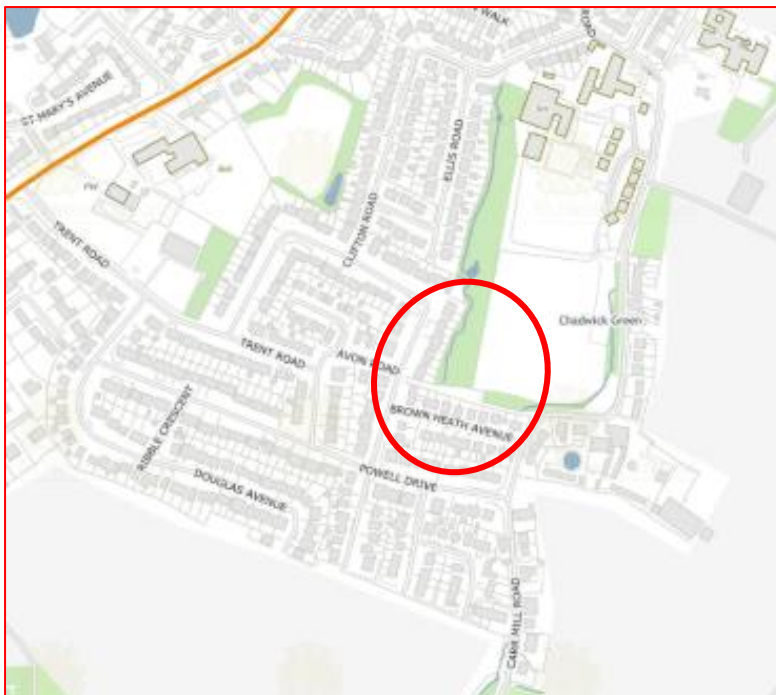
As noted, two streets were affected during this event, Brownheath Avenue and Powell Drive, located in the Billinge area of St Helens (*Figure 4*). Billinge is located in the north of the St Helens borough, close to Wigan.

Figure 4: Location of Flood Event

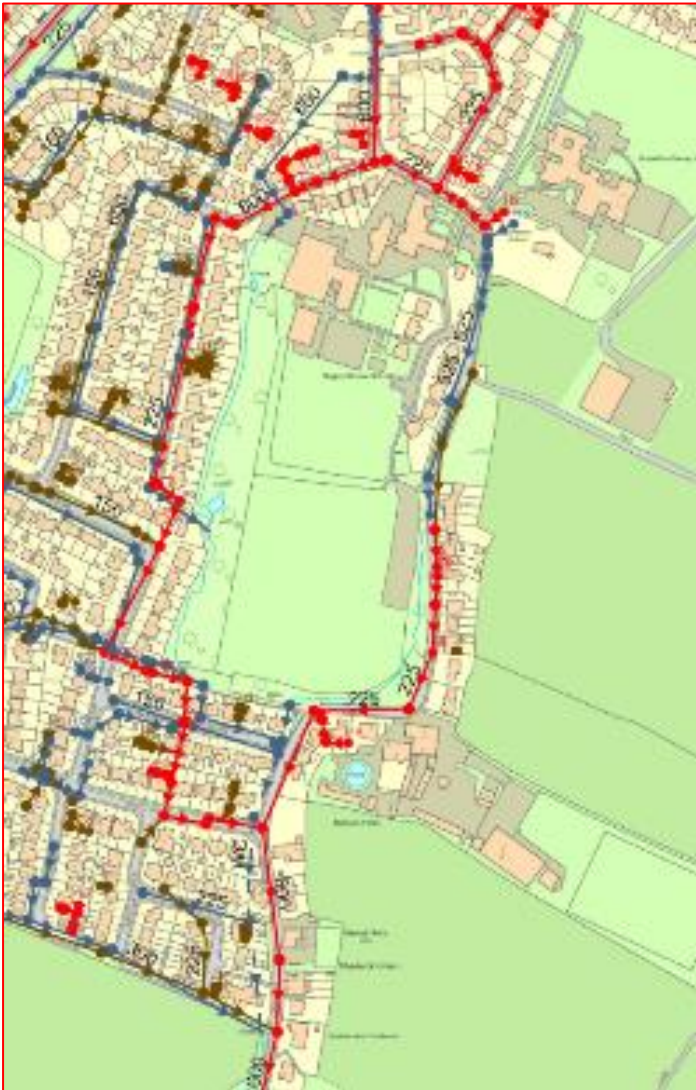
The Statutory Sewer Map was obtained from UU and shows the sewer network in the general area of the flood event (*Figure 6*). The area is drained via surface water and combined sewer networks. The UU Surface Water network connects to a culverted watercourse, which is the main drainage point for one of the affected watercourses during the event. The watercourse, which is located to the west, mainly holds water discharged from the UU network which then reconnects to drain into the UU Surface Water sewer network, just north of Brownheath Avenue. As shown on *Figure 6*, most of the network flows from north to south, following the topography of the area. There are several UU outfalls that discharge into the watercourses, upstream and downstream of the flooding location.<sup>5</sup>

Figure 6: UU Statutory Sewer Map

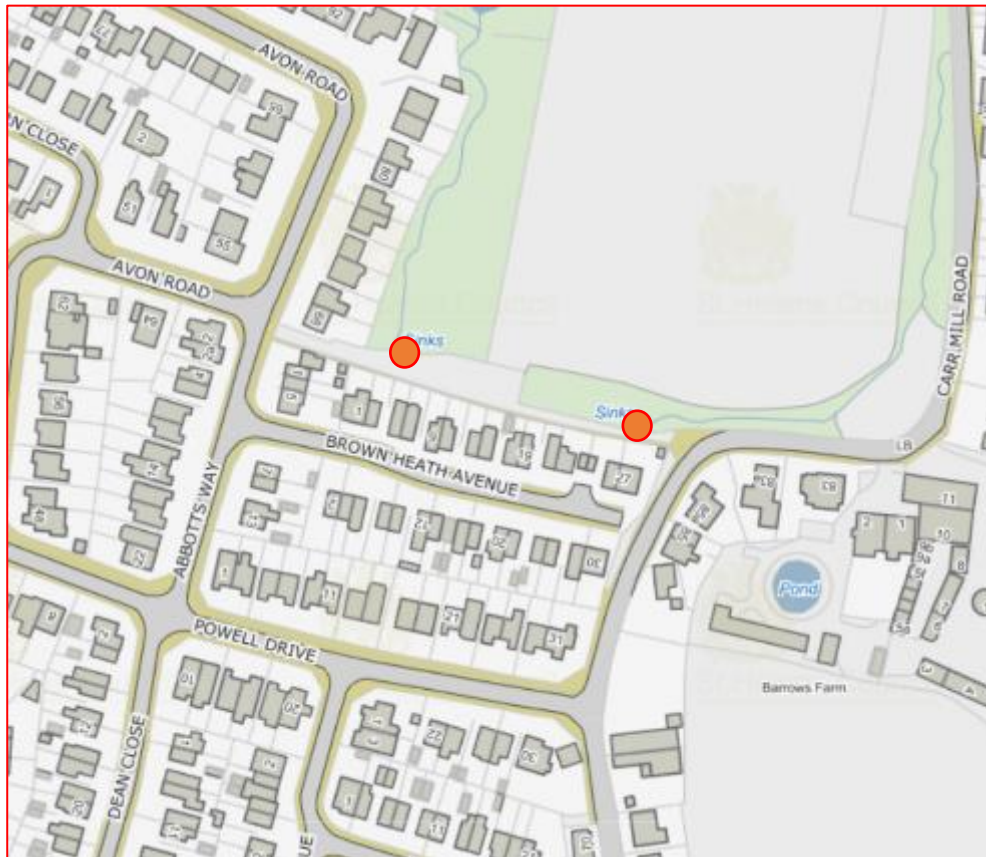
There are two watercourses in this section of Billinge that drain two separate areas, each with a different inlet point. Both culvert inlet points are accessed via privately owned land, see *Figure 7* for the inlet locations. <sup>6</sup>

*Figure 7: Culvert Inlets*

From discussions with the residents and in the MFRS incident reports, the blockage of the culvert inlets is believed to be one of the major contributing factors to the flood event, along with the high rainfall experienced by the area's drainage network. According to the anecdotal information, the blockage material comprised mainly of silt build-up, loose vegetation and, fly tipping materials. This blockage then resulted in the overtopping of the watercourses.

<b>ID</b>	<b>Action</b>	<b>Lead RMA (Support)</b>
1	Confirm land ownerships within the area.	St Helens Council
2	Arrange meetings with riparian landowners.	St Helens Council
3	Confirm appropriate maintenance roles and responsibilities.	St Helens Council
4	Confirm drainage catchment in the area and discuss with RMAs.	St Helens Council, UU
5	Investigate watercourse networks within the area.	St Helens Council, UU
6	Undertake discussions to review and strengthen emergency planning procedures.	St Helens Council
7	Potentially undertake flood study – identify mitigation measures, if possible.	St Helens Council, Landowner
8	Support the landowner to make the appropriate upgrades to the culvert screens and to conduct their maintenance.	St Helens Council, Landowner
9	Monitor flooding in the area.	St Helens Council, Landowner

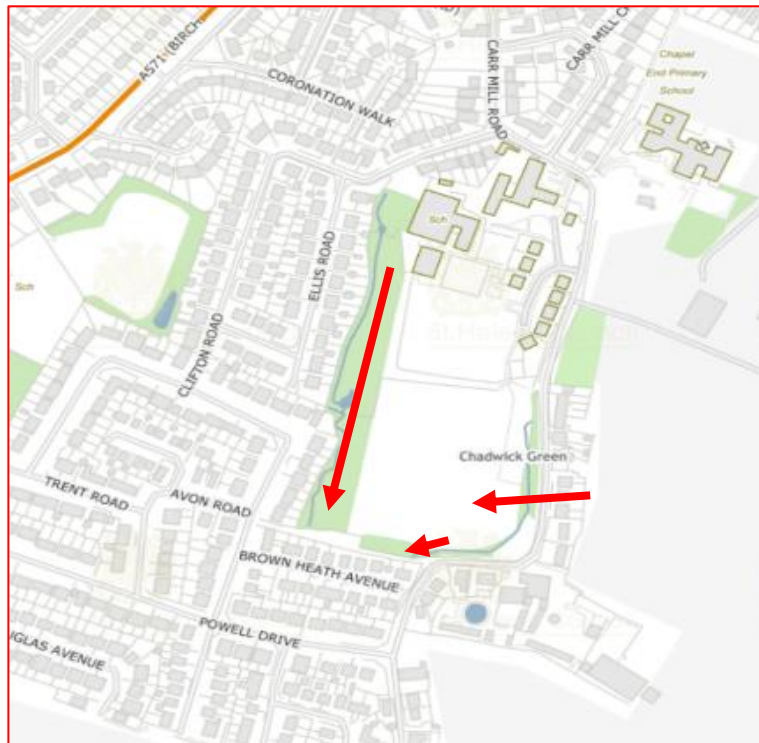
The floodwaters travelled southwards towards the public right of way, located to the rear of Brownheath, and then onto the Brownheath Avenue properties, following the natural topography of the area. Then the floodwaters migrated into the Brownheath Avenue adopted highway, where the volume of water was not able to drain away quick enough via the highway drainage network. The water depth, at its deepest, was between 2 to 3 feet deep in the roadway. The floodwaters moved southwards toward Powell Drive which in turn, knocked down the fences dividing Brownheath Avenue and Powell Drive. This created a wave of floodwater that moved toward the properties on Powell Drive and resulted in the internal flooding of the affected properties located on Powell Drive. The floodwater then drained back into the watercourse when it reached the adopted highway drainage network on Powell Drive and the connecting highway. Once the culverts were cleared of debris by the MFRS, it was reported that the the watercourse ceased to overtop which allowed the drainage network on Brownheath Avenue and Powell Drive to drain the existing floodwaters.

Furthermore, residents also reported that field drainage from the land to the north-east of the affected area, added to overall volume of floodwater. *Figure 8* shows the believed general routes taken by the floodwater on the day of the flood event.<sup>7</sup>

*Figure 8: General Flood Mechanism for the Flood Event*
