Walled Garden From the Park/Proposed Band Stand

Walled Garden From the Conservatory

NPS Group (Kendal)
Aynam Mills, Little Aynam
Kendal, Cumbria
LA9 7AH

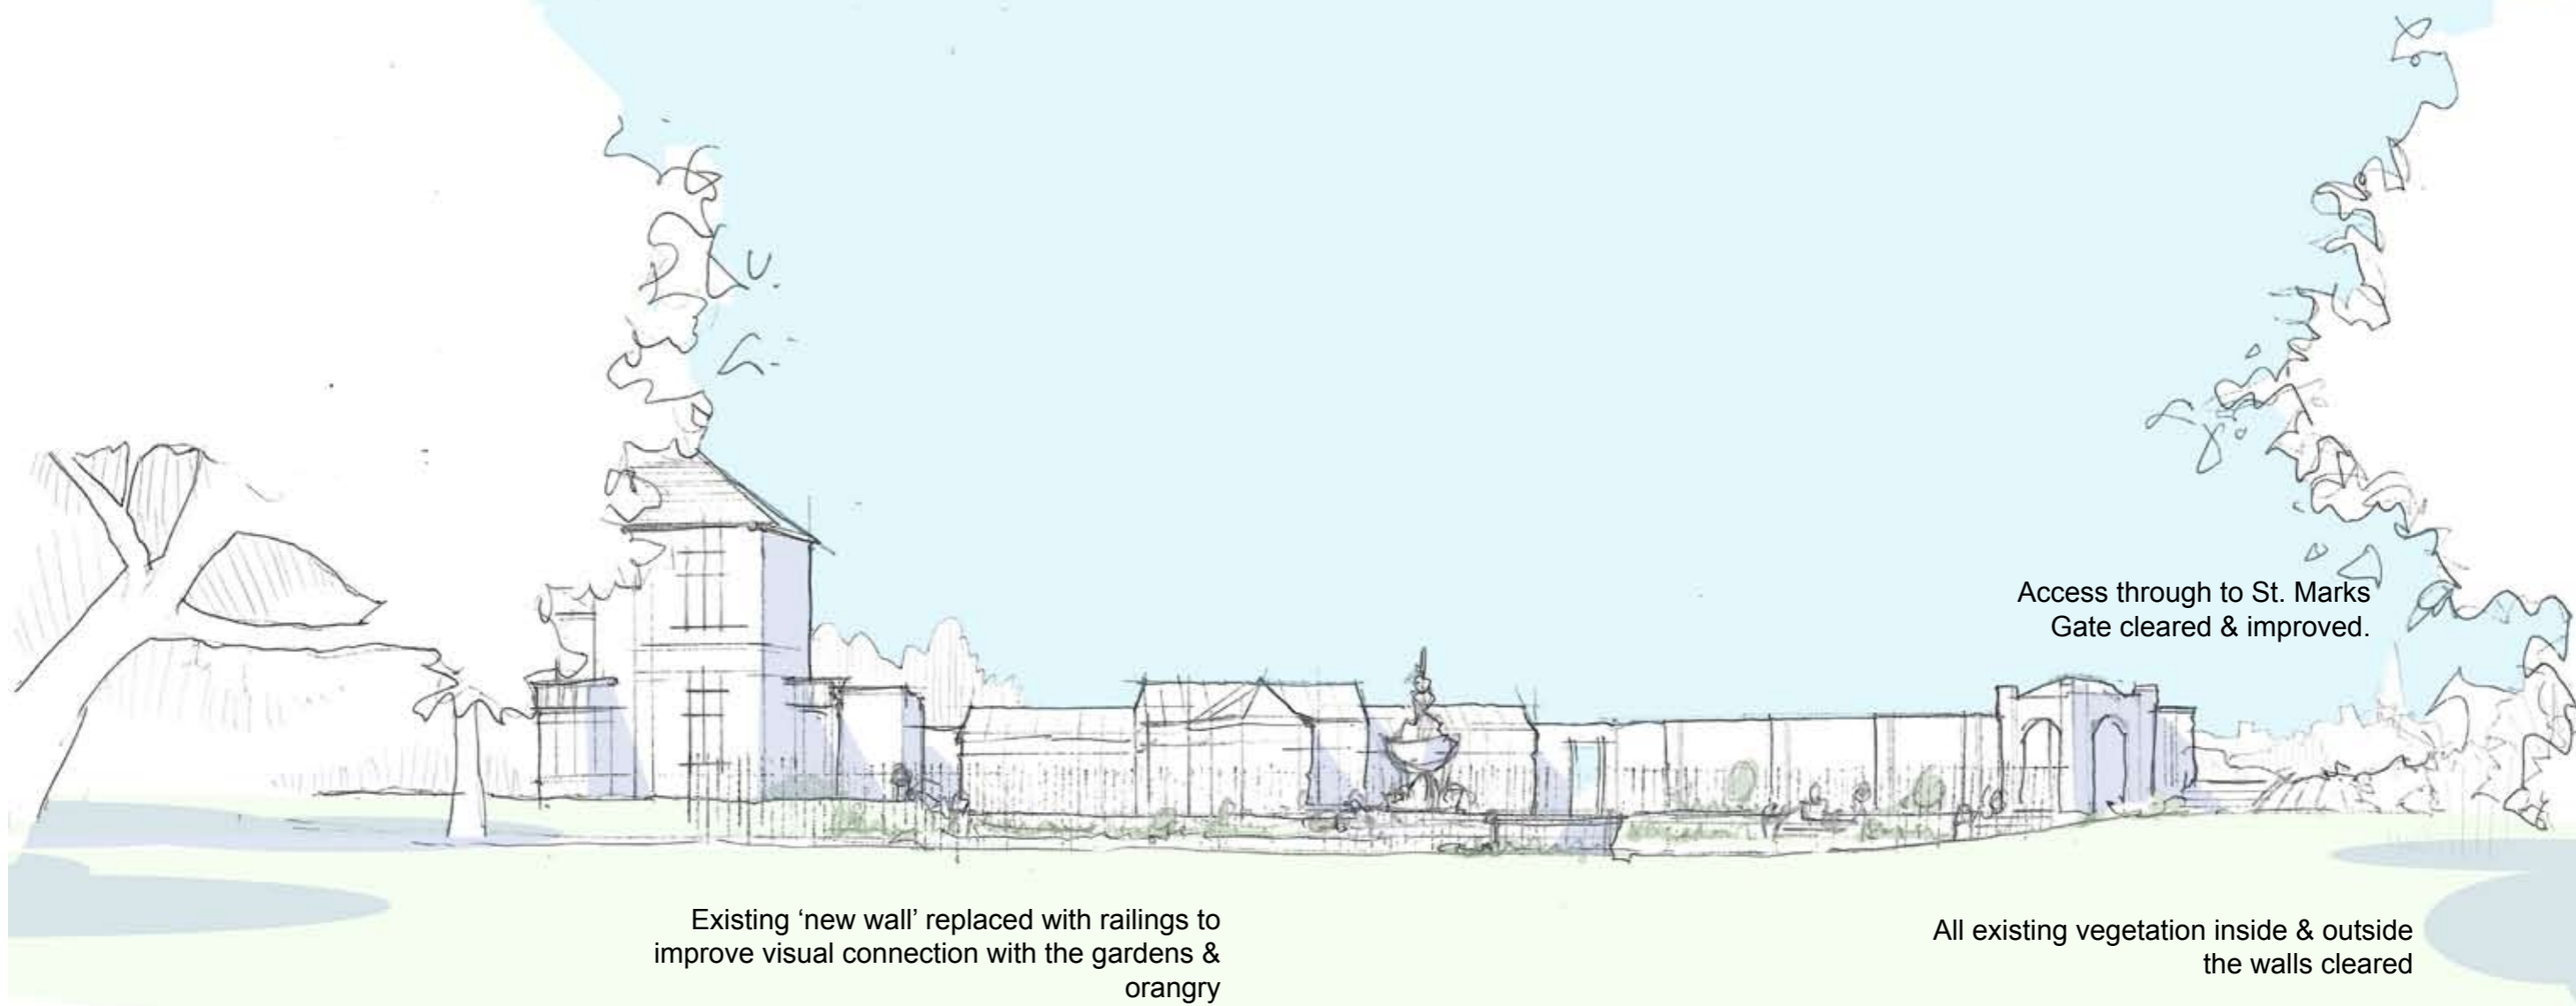
Existing 'new wall' replaced with railings to improve visual connection with the gardens & orangry

Access through to St. Marks Gate cleared & improved.

All existing vegetation inside & outside the walls cleared

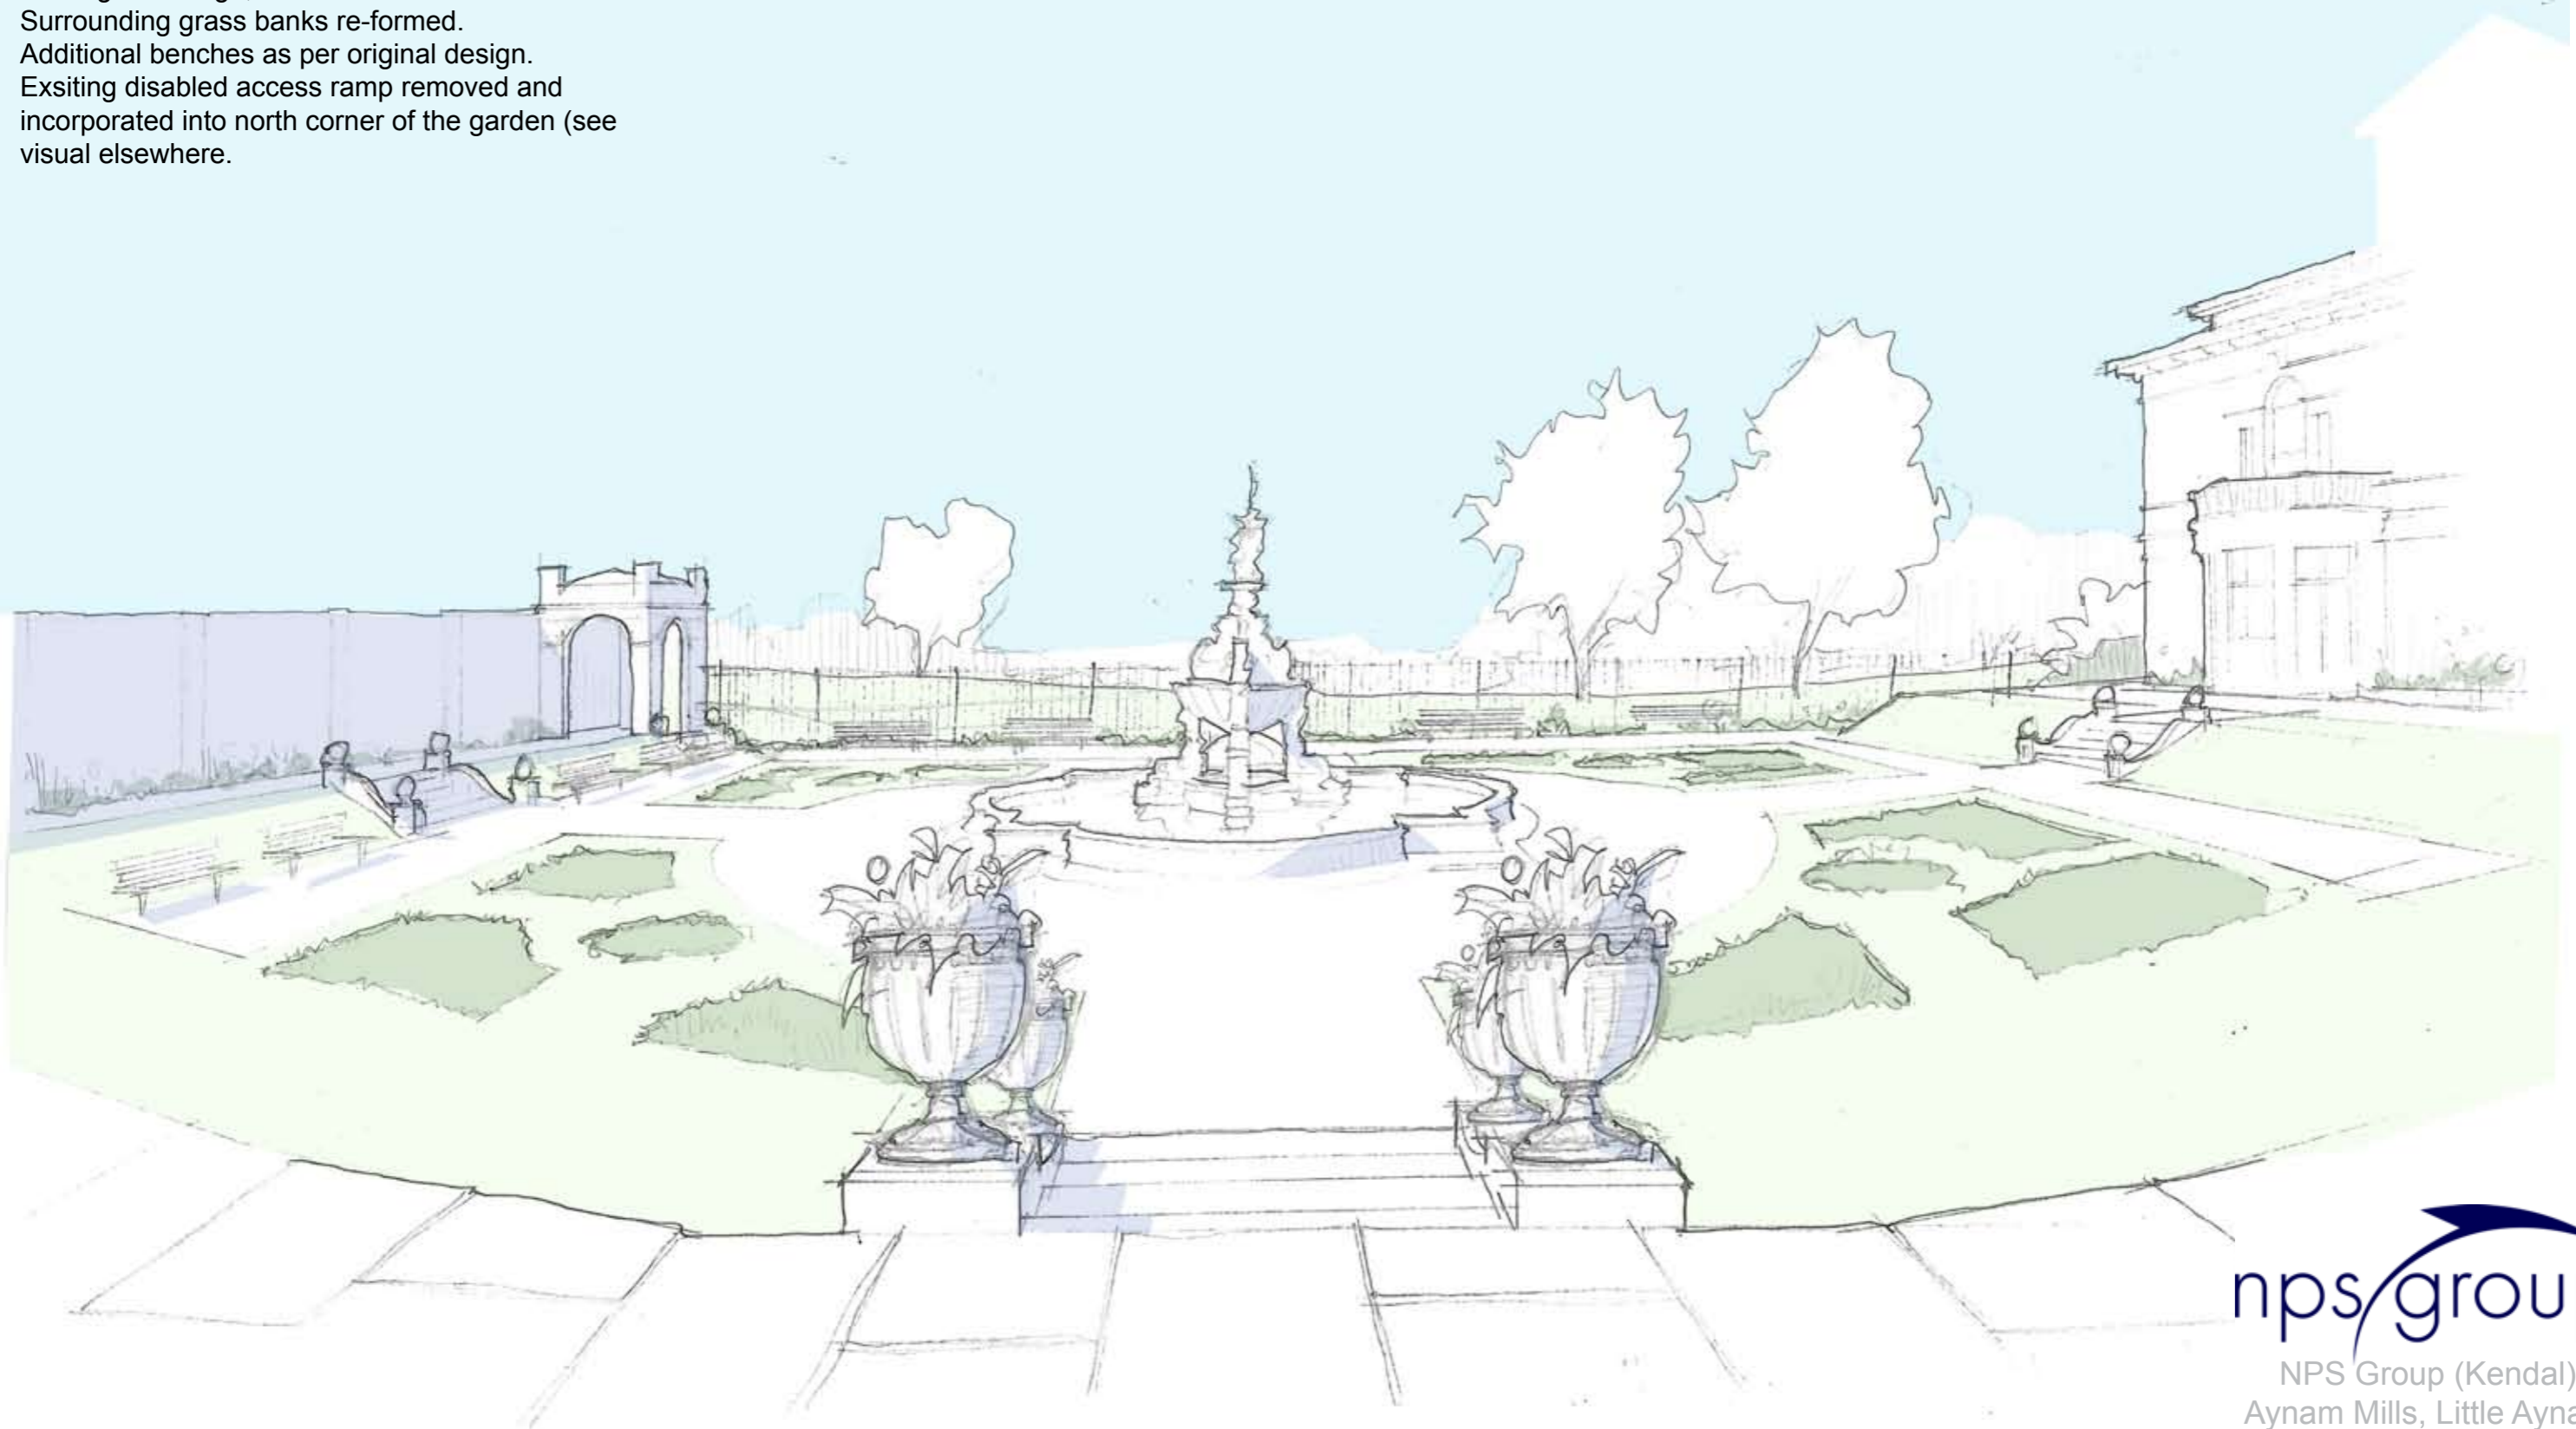
View showing garden restored to circa. 1880's but with the addition of railings to replace the 'new' wall....
Seat detail relocated from the front of the orangery back to as close as possible to it's original position.
New seats fitted at front approach to orangery as per the original design,
Surrounding grass banks re-formed.
Additional benches as per original design.
Exsiting disabled access ramp removed and incorporated into north corner of the garden (see visual elsewhere).

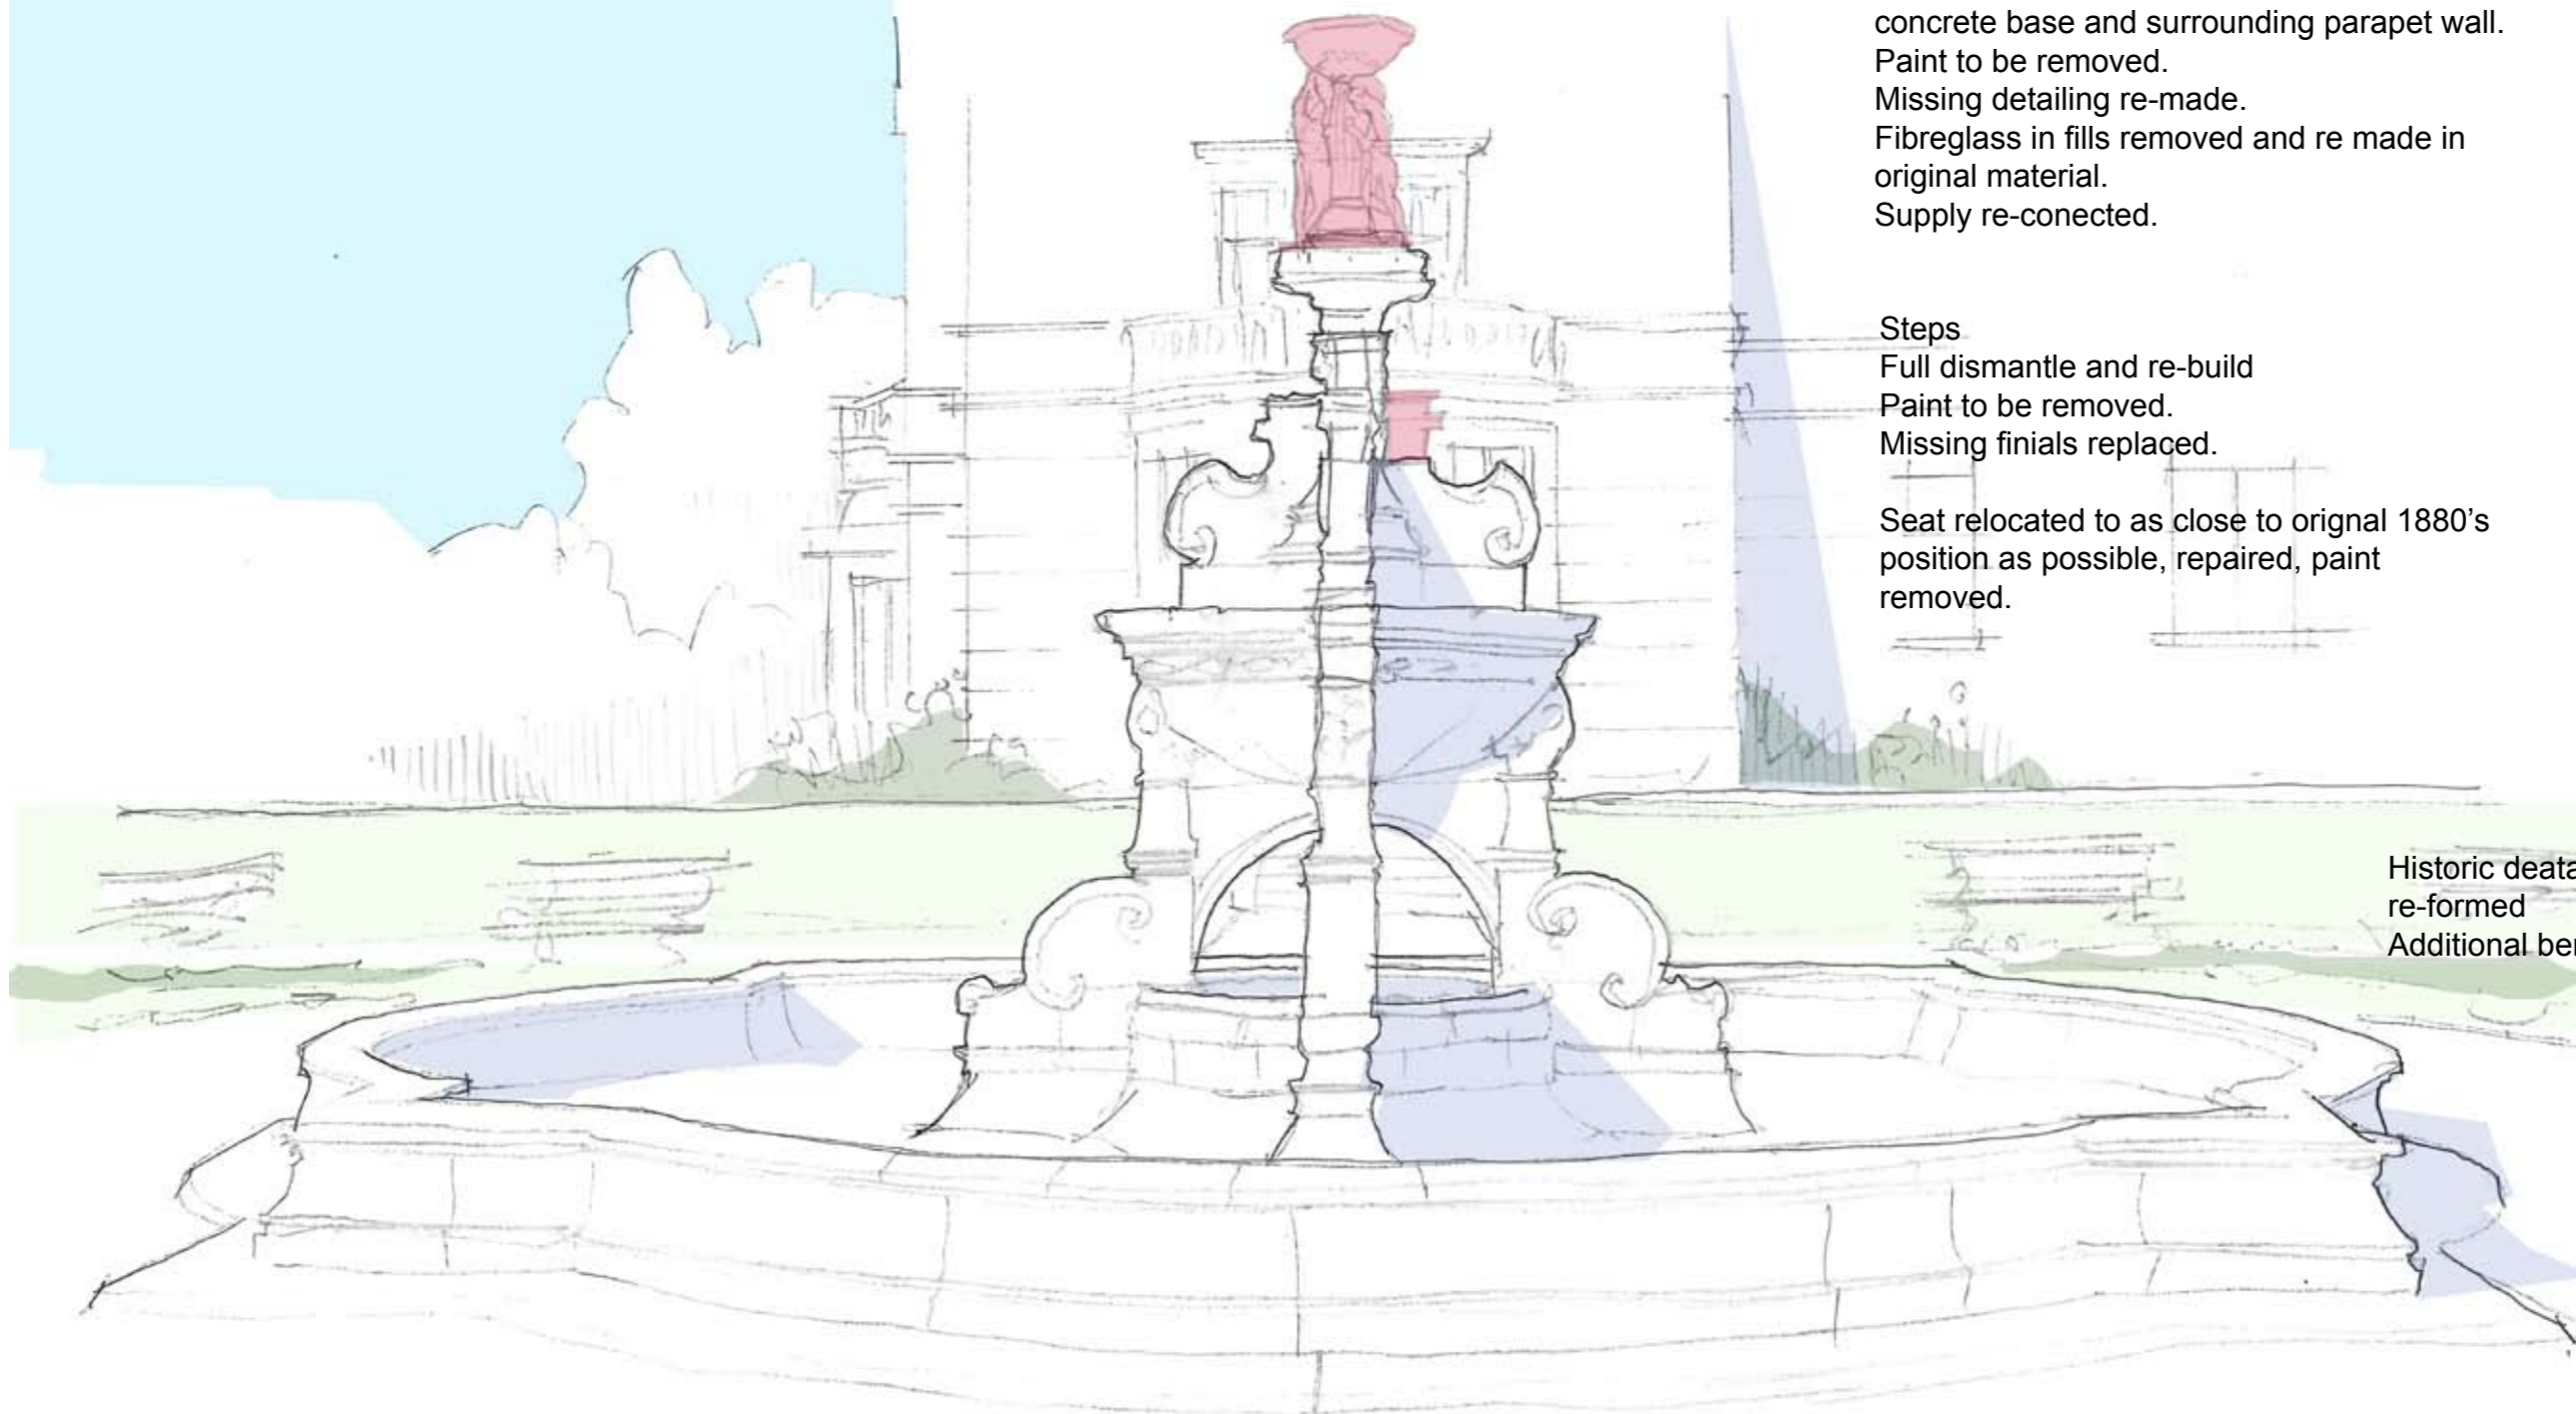
Re-furbished Fountain

Full dismantle and re-build of fountain,
concrete base and surrounding parapet wall.
Paint to be removed.
Missing detailing re-made.
Fibreglass in fills removed and re made in
original material.
Supply re-connected.

Steps

Full dismantle and re-build
Paint to be removed.
Missing finials replaced.

Seat relocated to as close to original 1880's
position as possible, repaired, paint
removed.

Historic detail of grass bank to garden edge
re-formed
Additional benches as per original layout

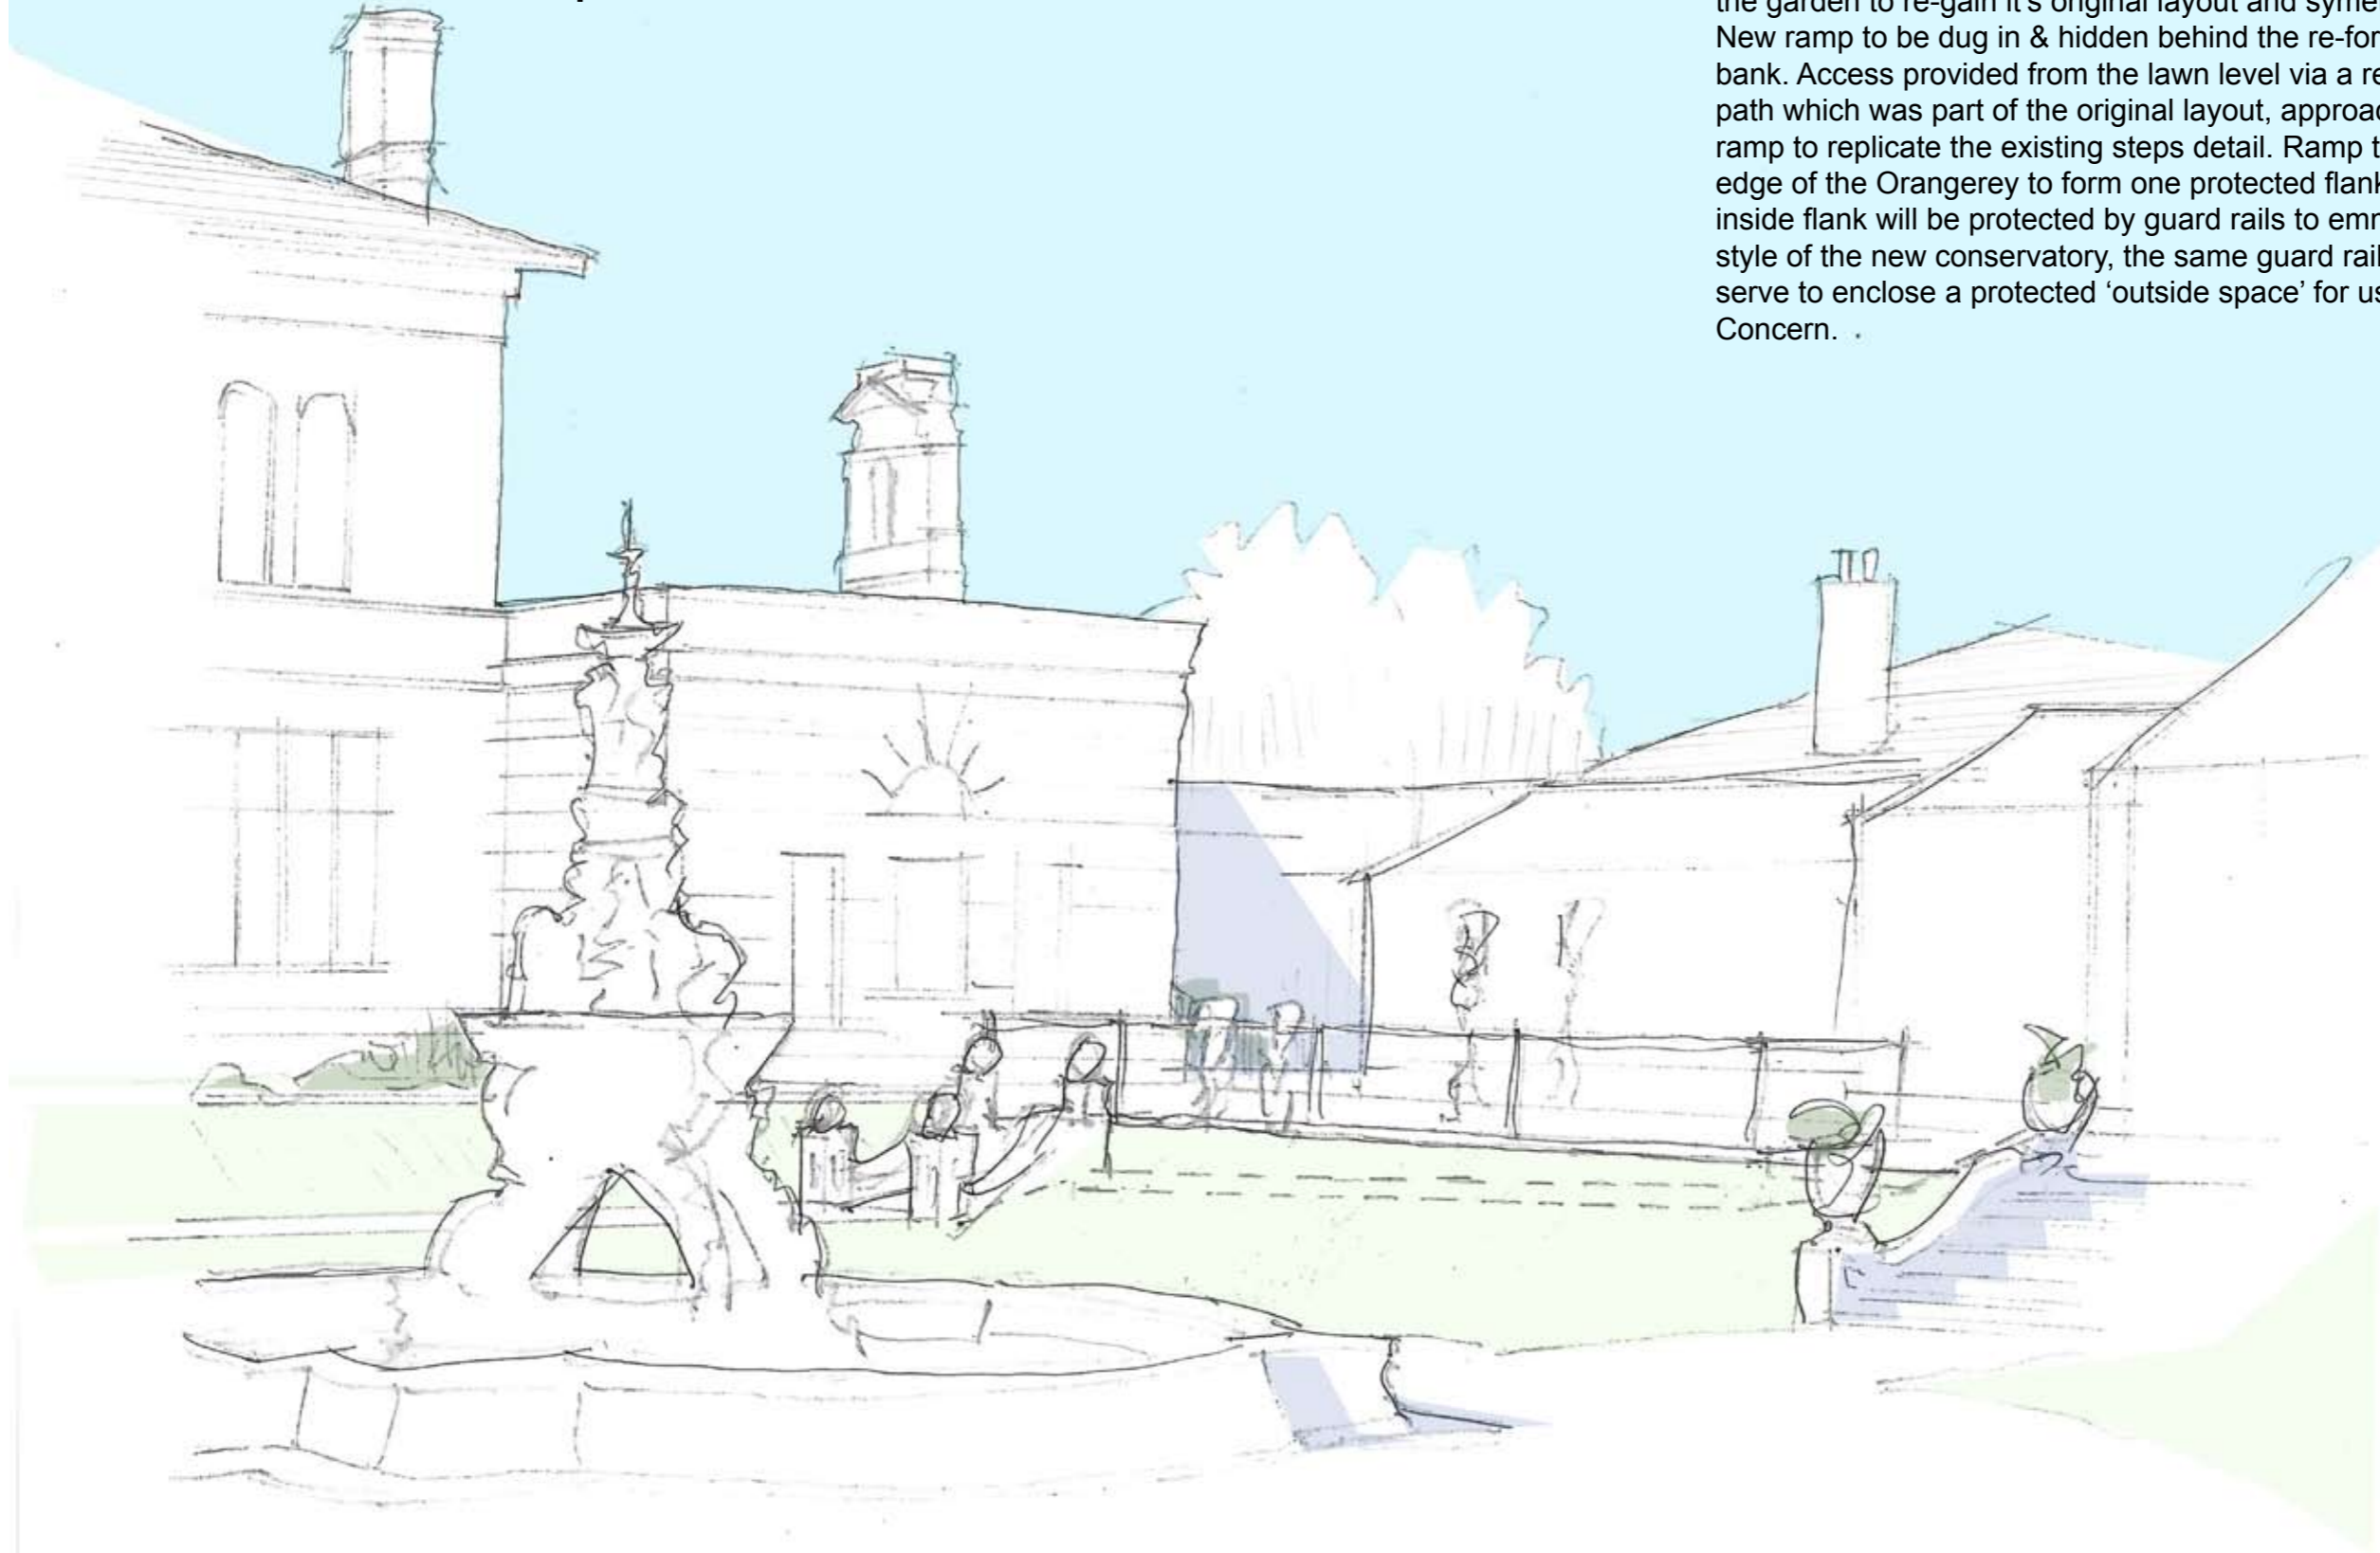
New Disabled Ramp Access to Walled Garden

Disabled access removed from it's existing position to allow the garden to re-gain it's original layout and symetry. New ramp to be dug in & hidden behind the re-formed grass bank. Access provided from the lawn level via a re-formed path which was part of the original layout, approach to the ramp to replicate the existing steps detail. Ramp to follow the edge of the Orangerey to form one protected flank while the inside flank will be protected by guard rails to emmulate the style of the new conservatory, the same guard rail will also serve to enclose a protected 'outside space' for use by Age Concern. .

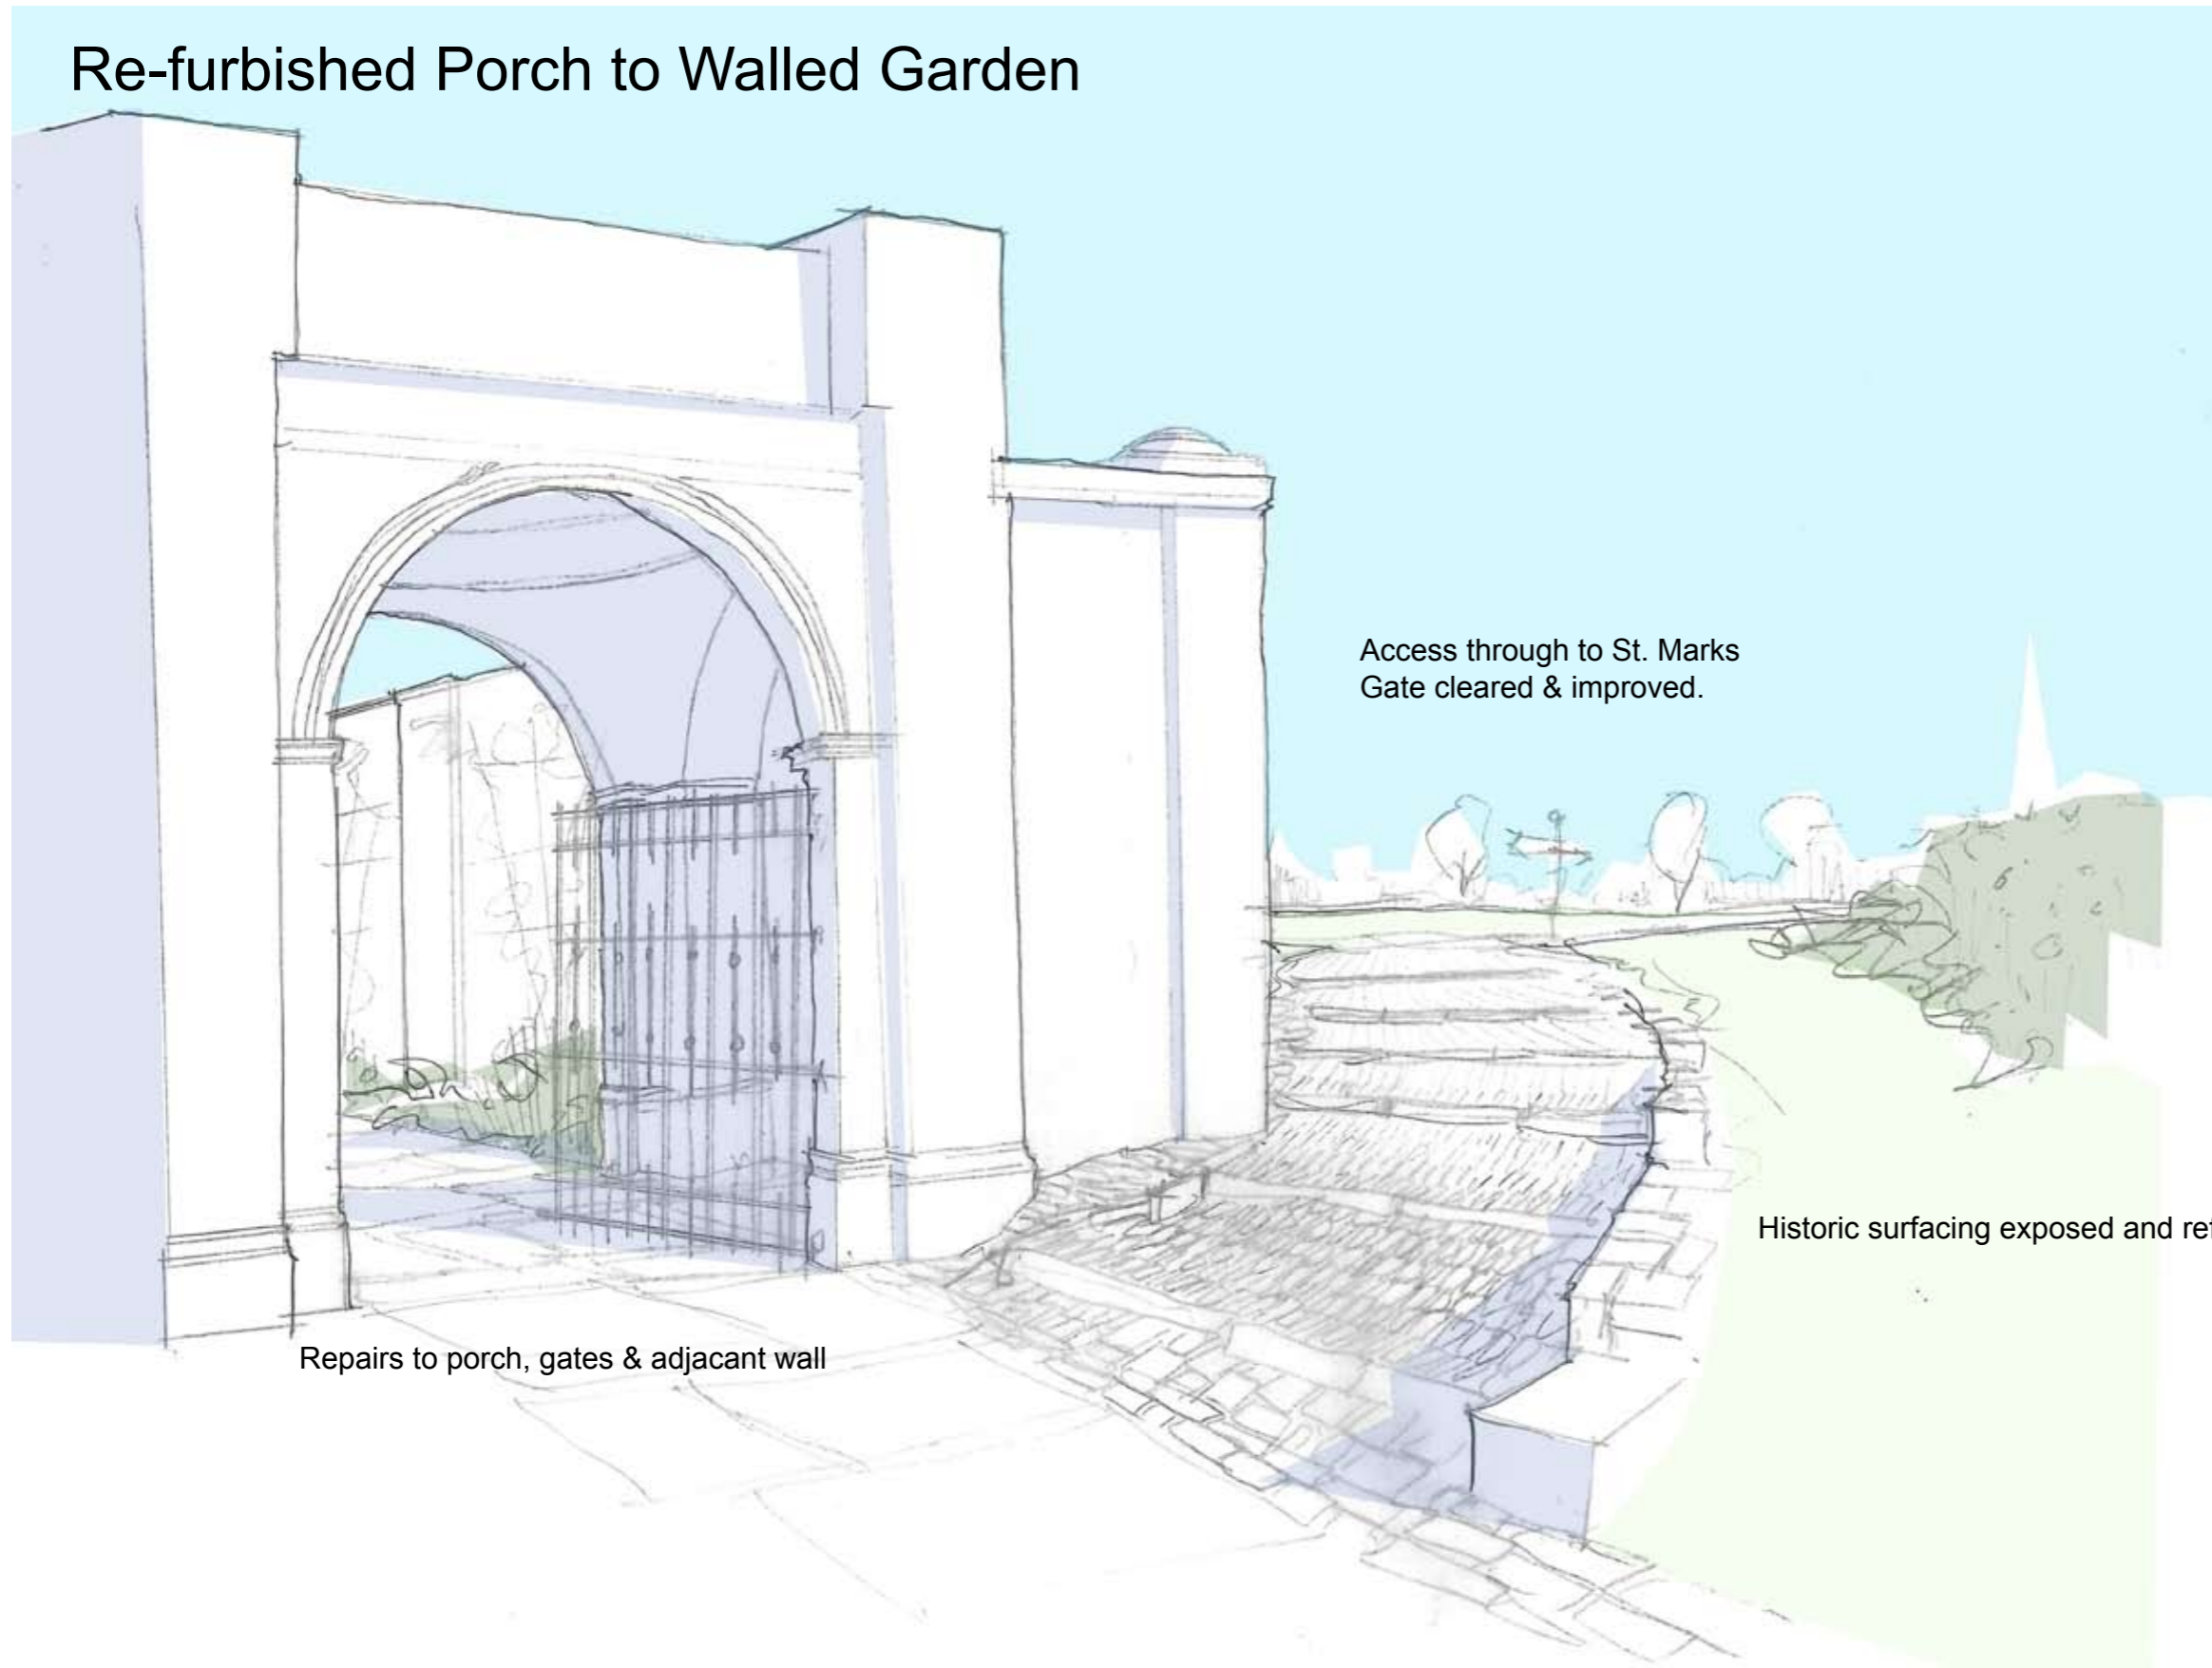
Re-furbished Porch to Walled Garden

Repairs to porch, gates & adjacent wall

Access through to St. Marks Gate cleared & improved.

Historic surfacing exposed and refurbished

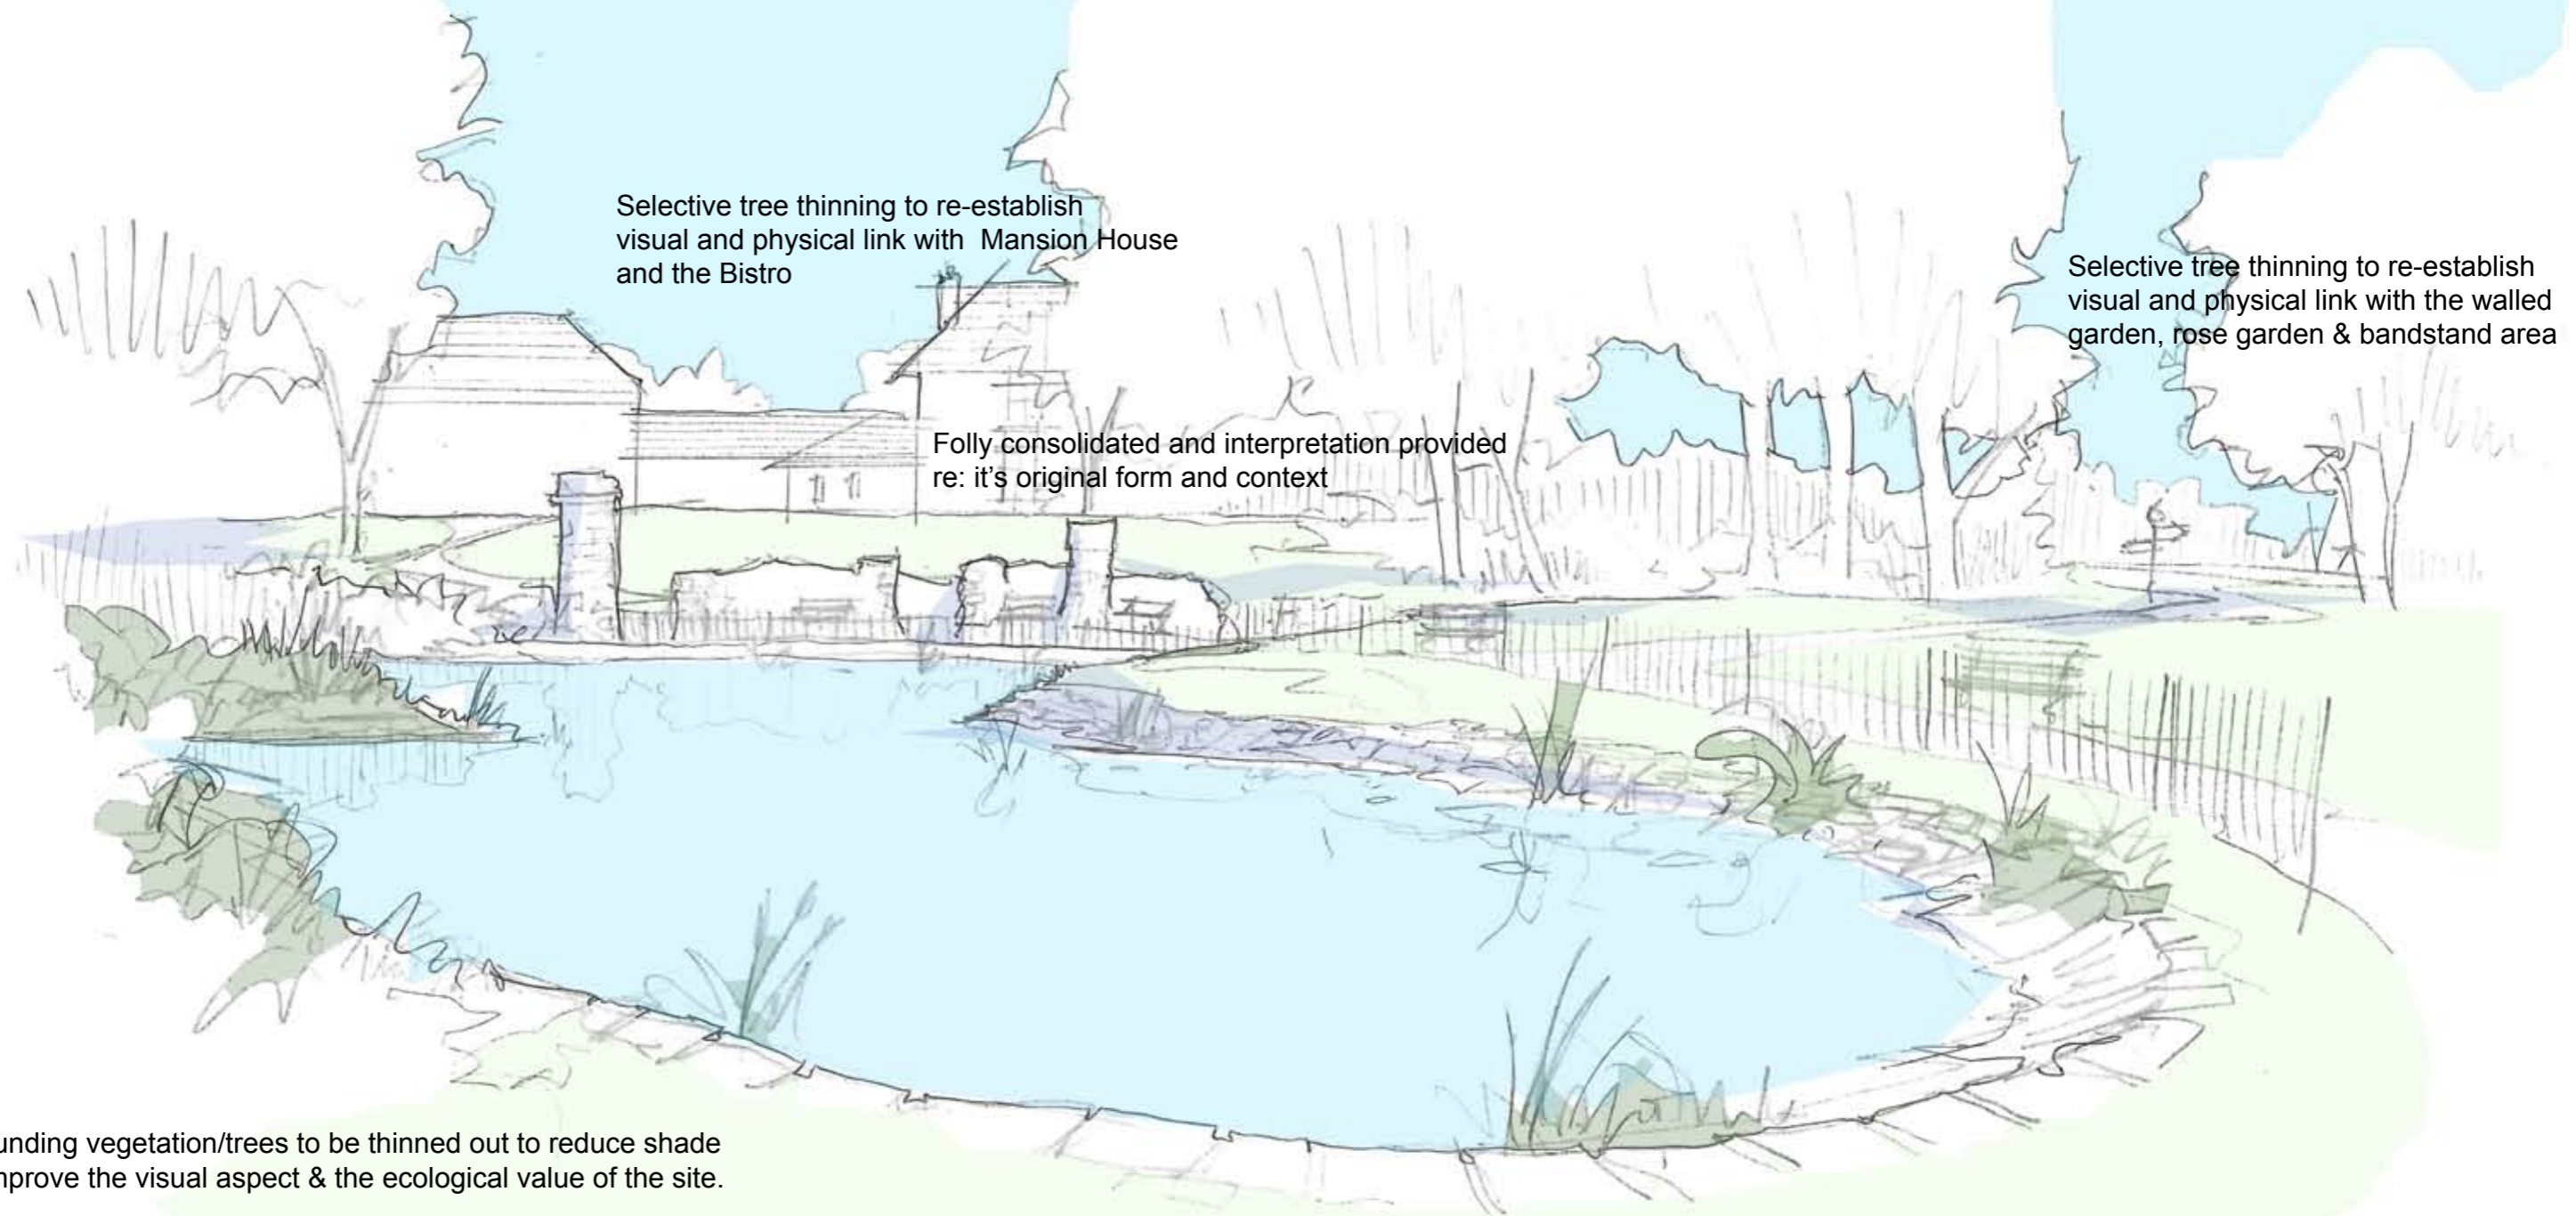
Re-furbished Pond

Selective tree thinning to re-establish visual and physical link with Mansion House and the Bistro

Folly consolidated and interpretation provided re: it's original form and context

Selective tree thinning to re-establish visual and physical link with the walled garden, rose garden & bandstand area

Surrounding vegetation/trees to be thinned out to reduce shade and improve the visual aspect & the ecological value of the site.

New planting around pond edge to concentrate on marginal & semi-aquatic species to improve ecological value & water quality

Pond to be drained, cleared of silt/debris and concrete banks removed and re-built in sloping rough dress stone as per historic detail and to improve ecological value.

Surrounding railings re-paired/re-furbished and new seating provided as per original park layout.

All historic surfacing/edgings where evident to be exposed, and re-furbished.
