Walled Garden From the Park/Proposed Band Stand

Walled Garden From the Conservatory

NPS Group (Kendal)
Aynam Mills, Little Aynam
Kendal, Cumbria
LA9 7AH

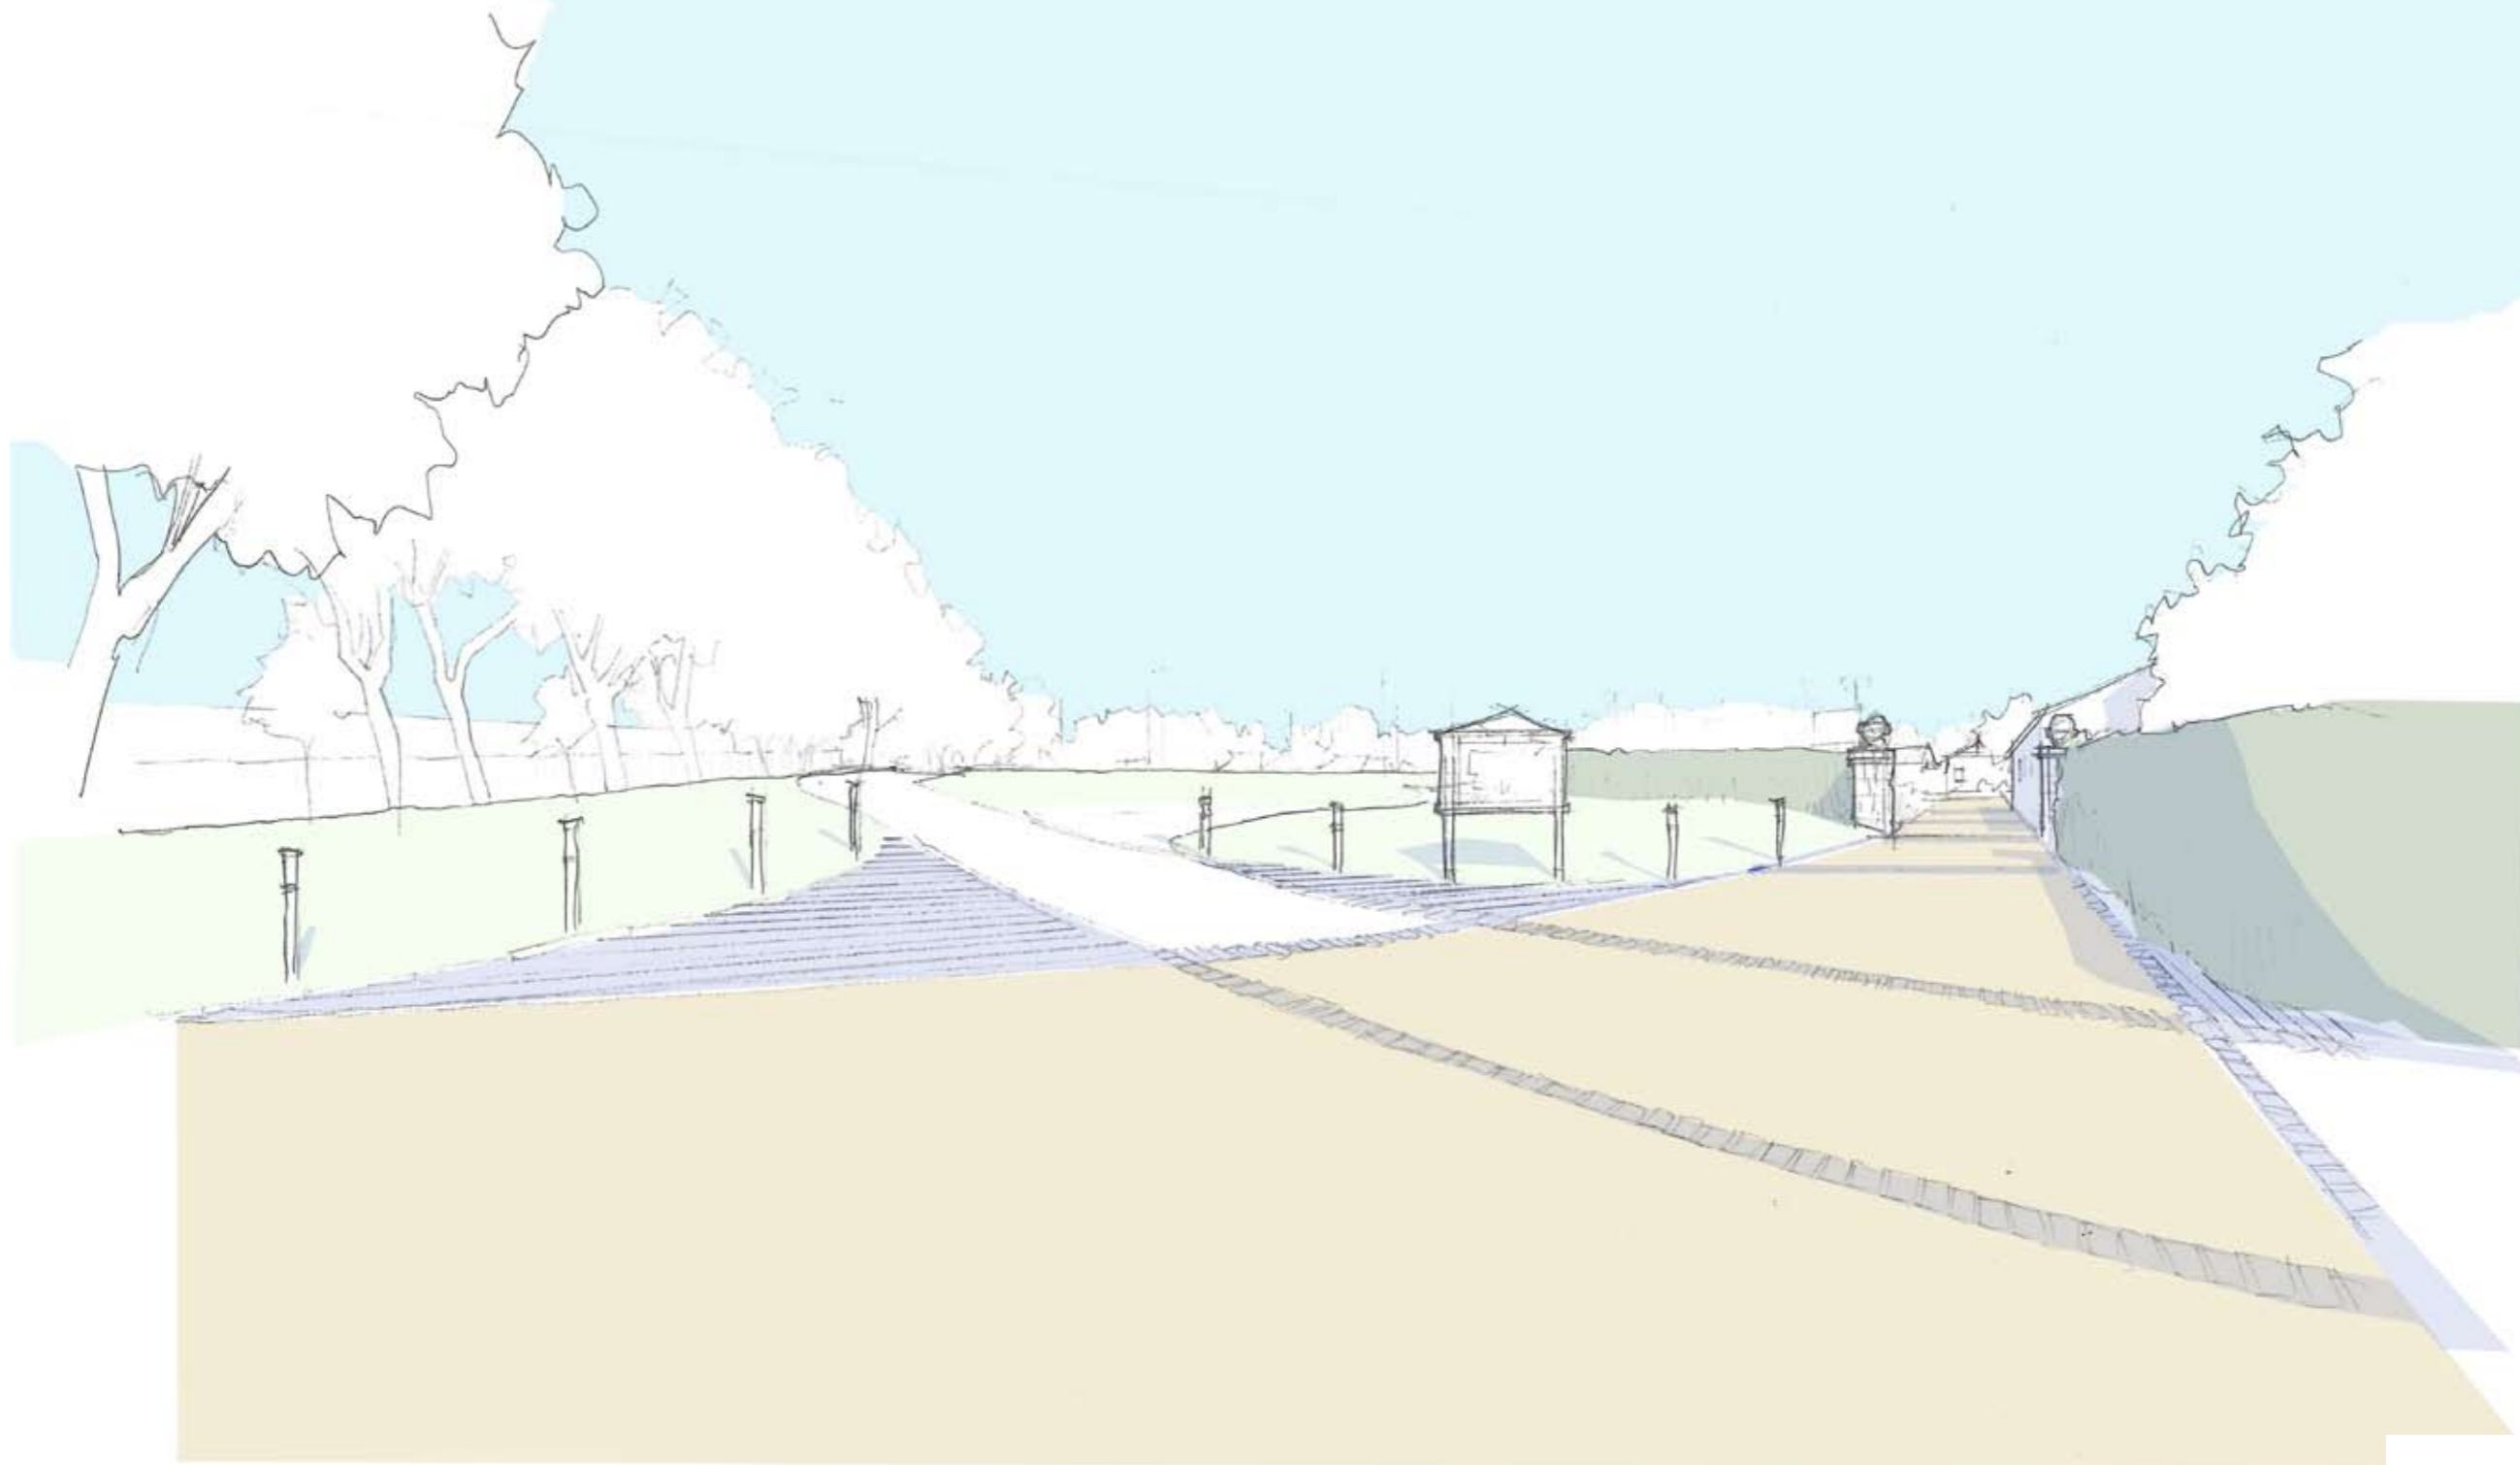
New Approach to Mansion House from City Road

Use of new surfacing/textures/patterns to strengthen the visual link to Mansion House and to enhance the line of the existing 'circuit path' around the edge of the park.

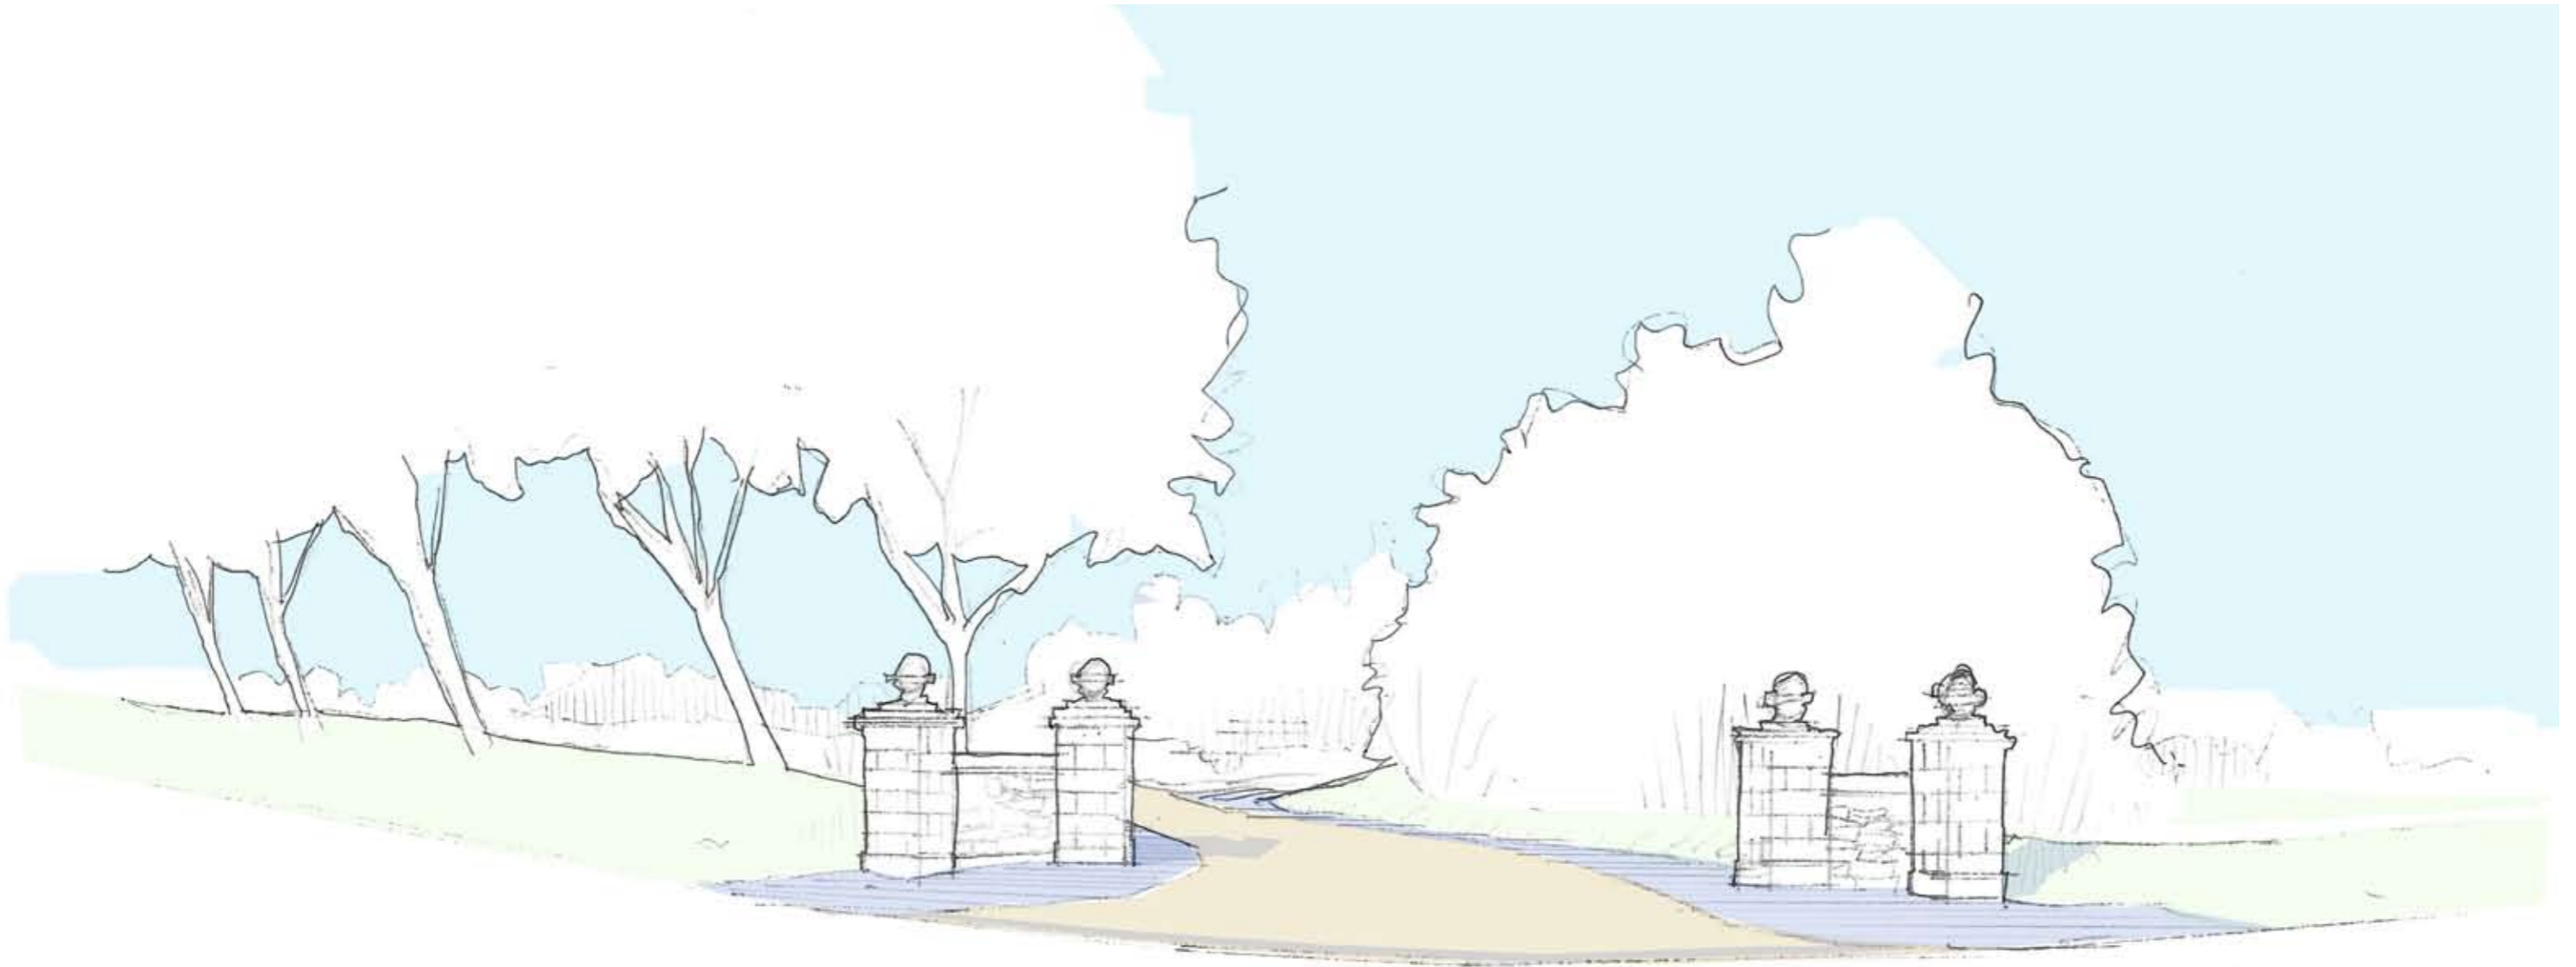
Re-formed City Road Entrance

Re-forming the former gates from City Road, removing the existing roadside pavement to promote footfall through the park and using the same surface treatment to enhance the visual/movement link with Mansion House

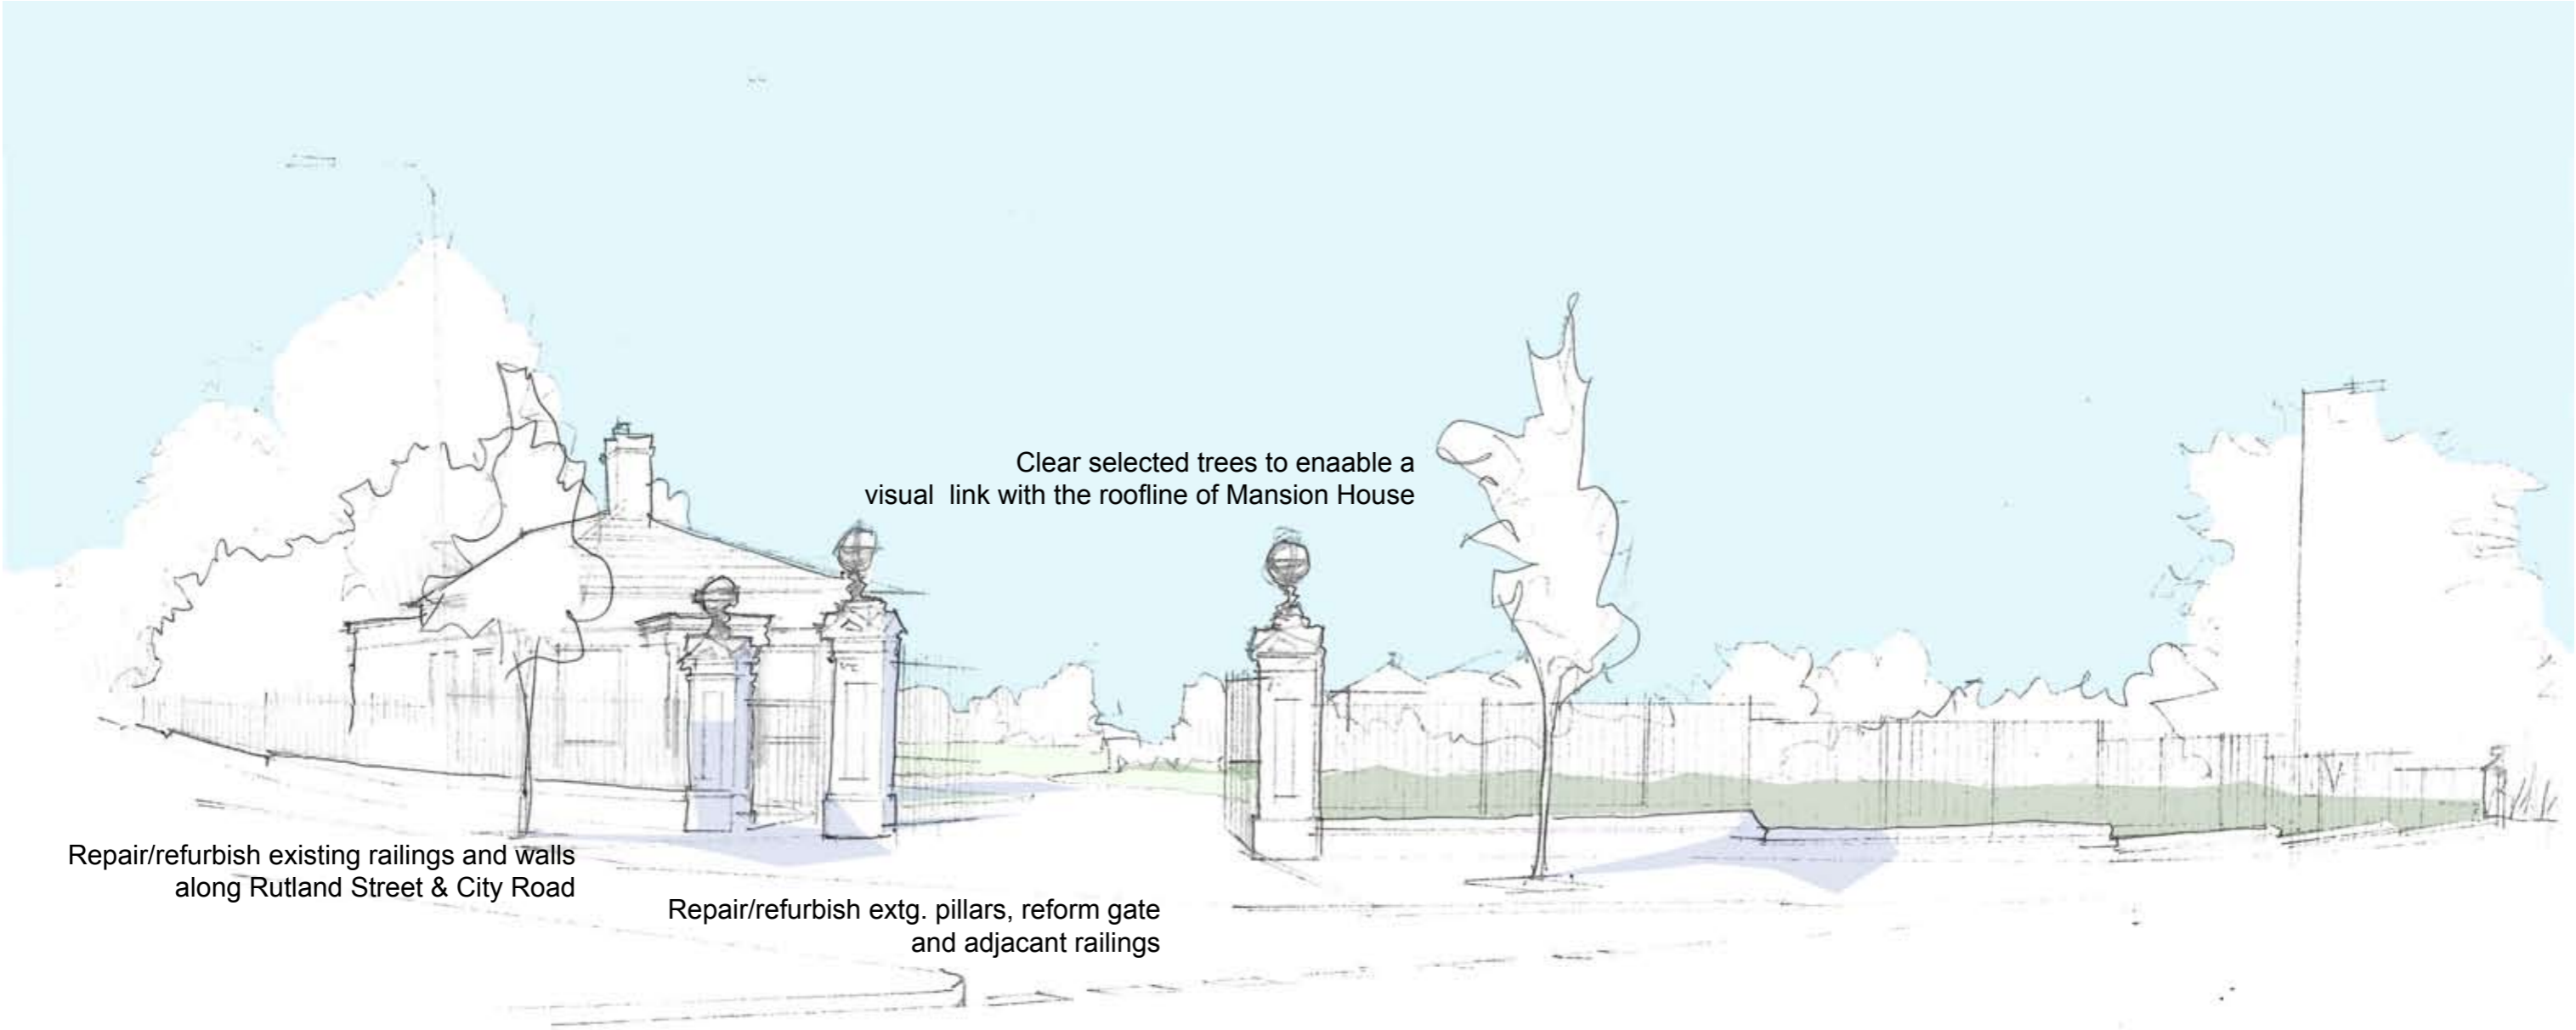
Re-furbished St Marks Entrance

Repair/refurbish existing railings and walls along Rutland Street & City Road

Repair/refurbish extg. pillars, reform gate and adjacent railings

Clear selected trees to enable a visual link with the roofline of Mansion House

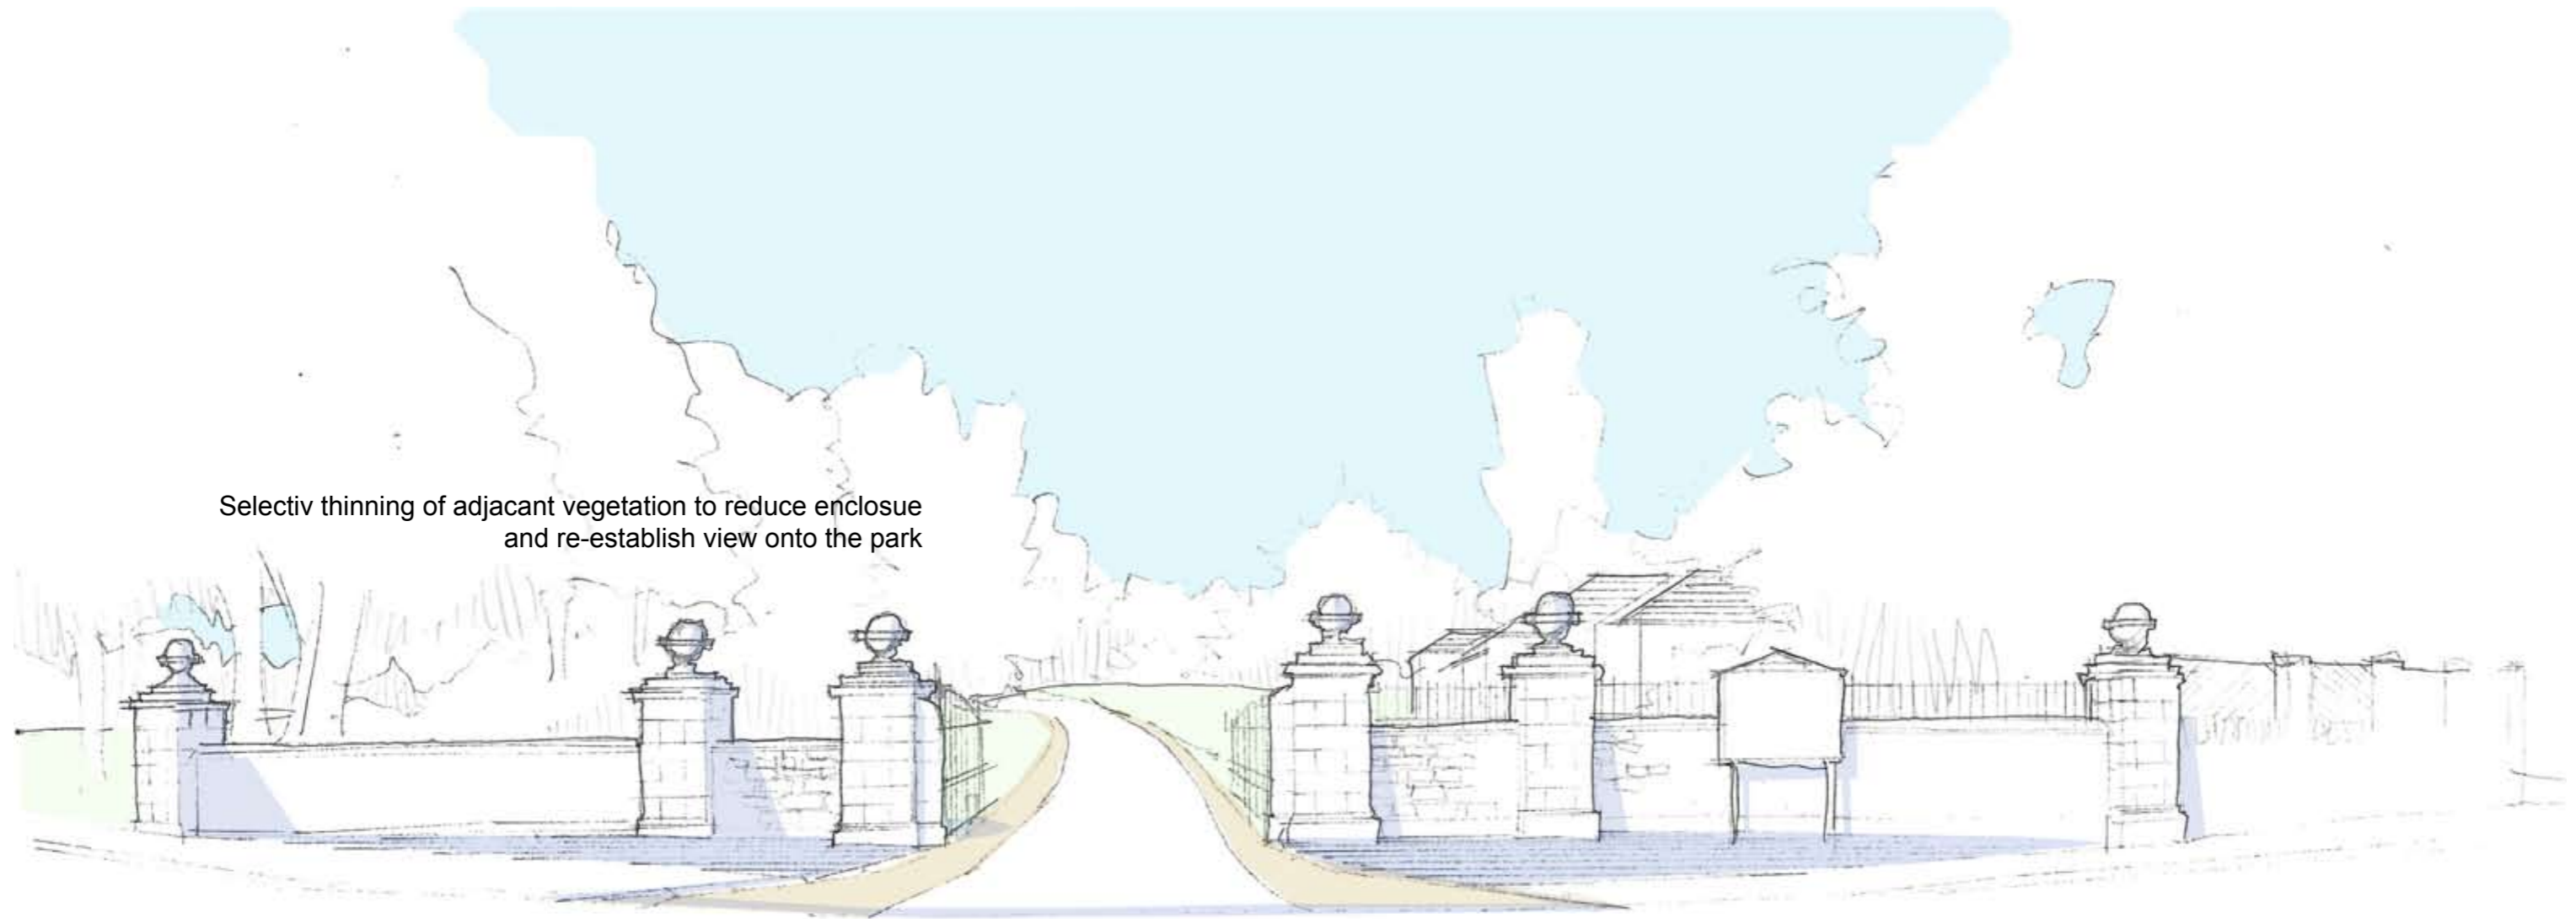
Re-furbished Windlehurst Gate

Selectiv thinning of adjacent vegetation to reduce enclosue and re-establish view onto the park

Repair/refurbish existing pillars & reform gate, some minor surface treatment to create focus up the drive into the park to enhance the route past the lodge building.

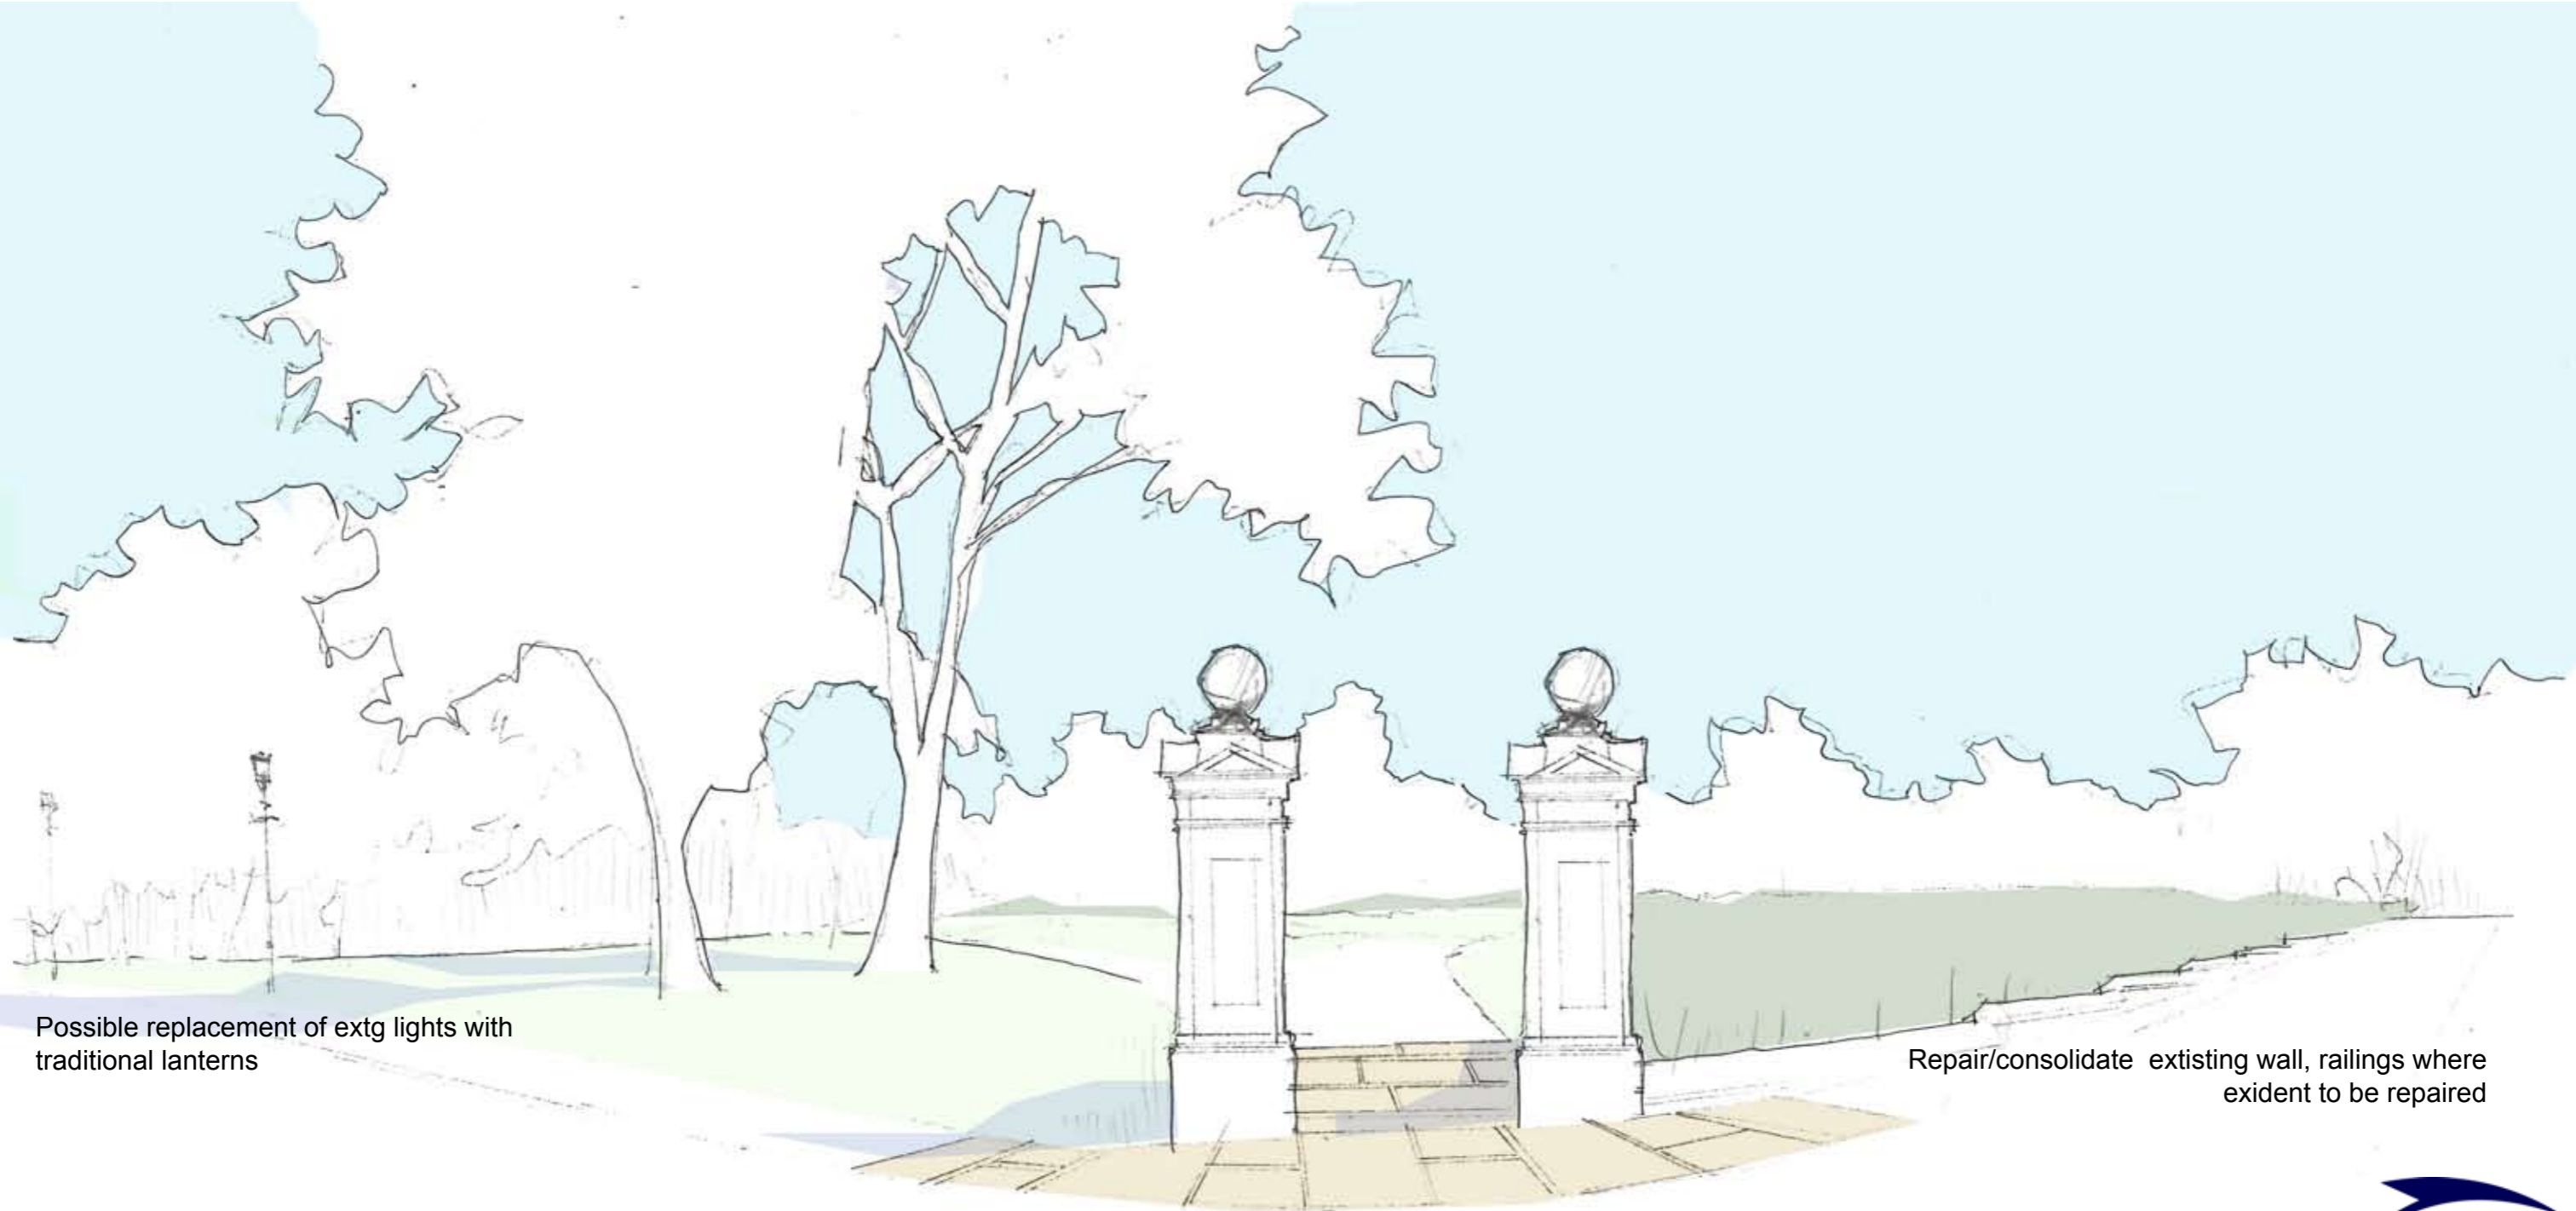
Re-furbished Balker Gate

Possible replacement of extg lights with traditional lanterns

Repair/consolidate existing wall, railings where exident to be repaired

Repair/refurbish existing pillars at Balker Gate

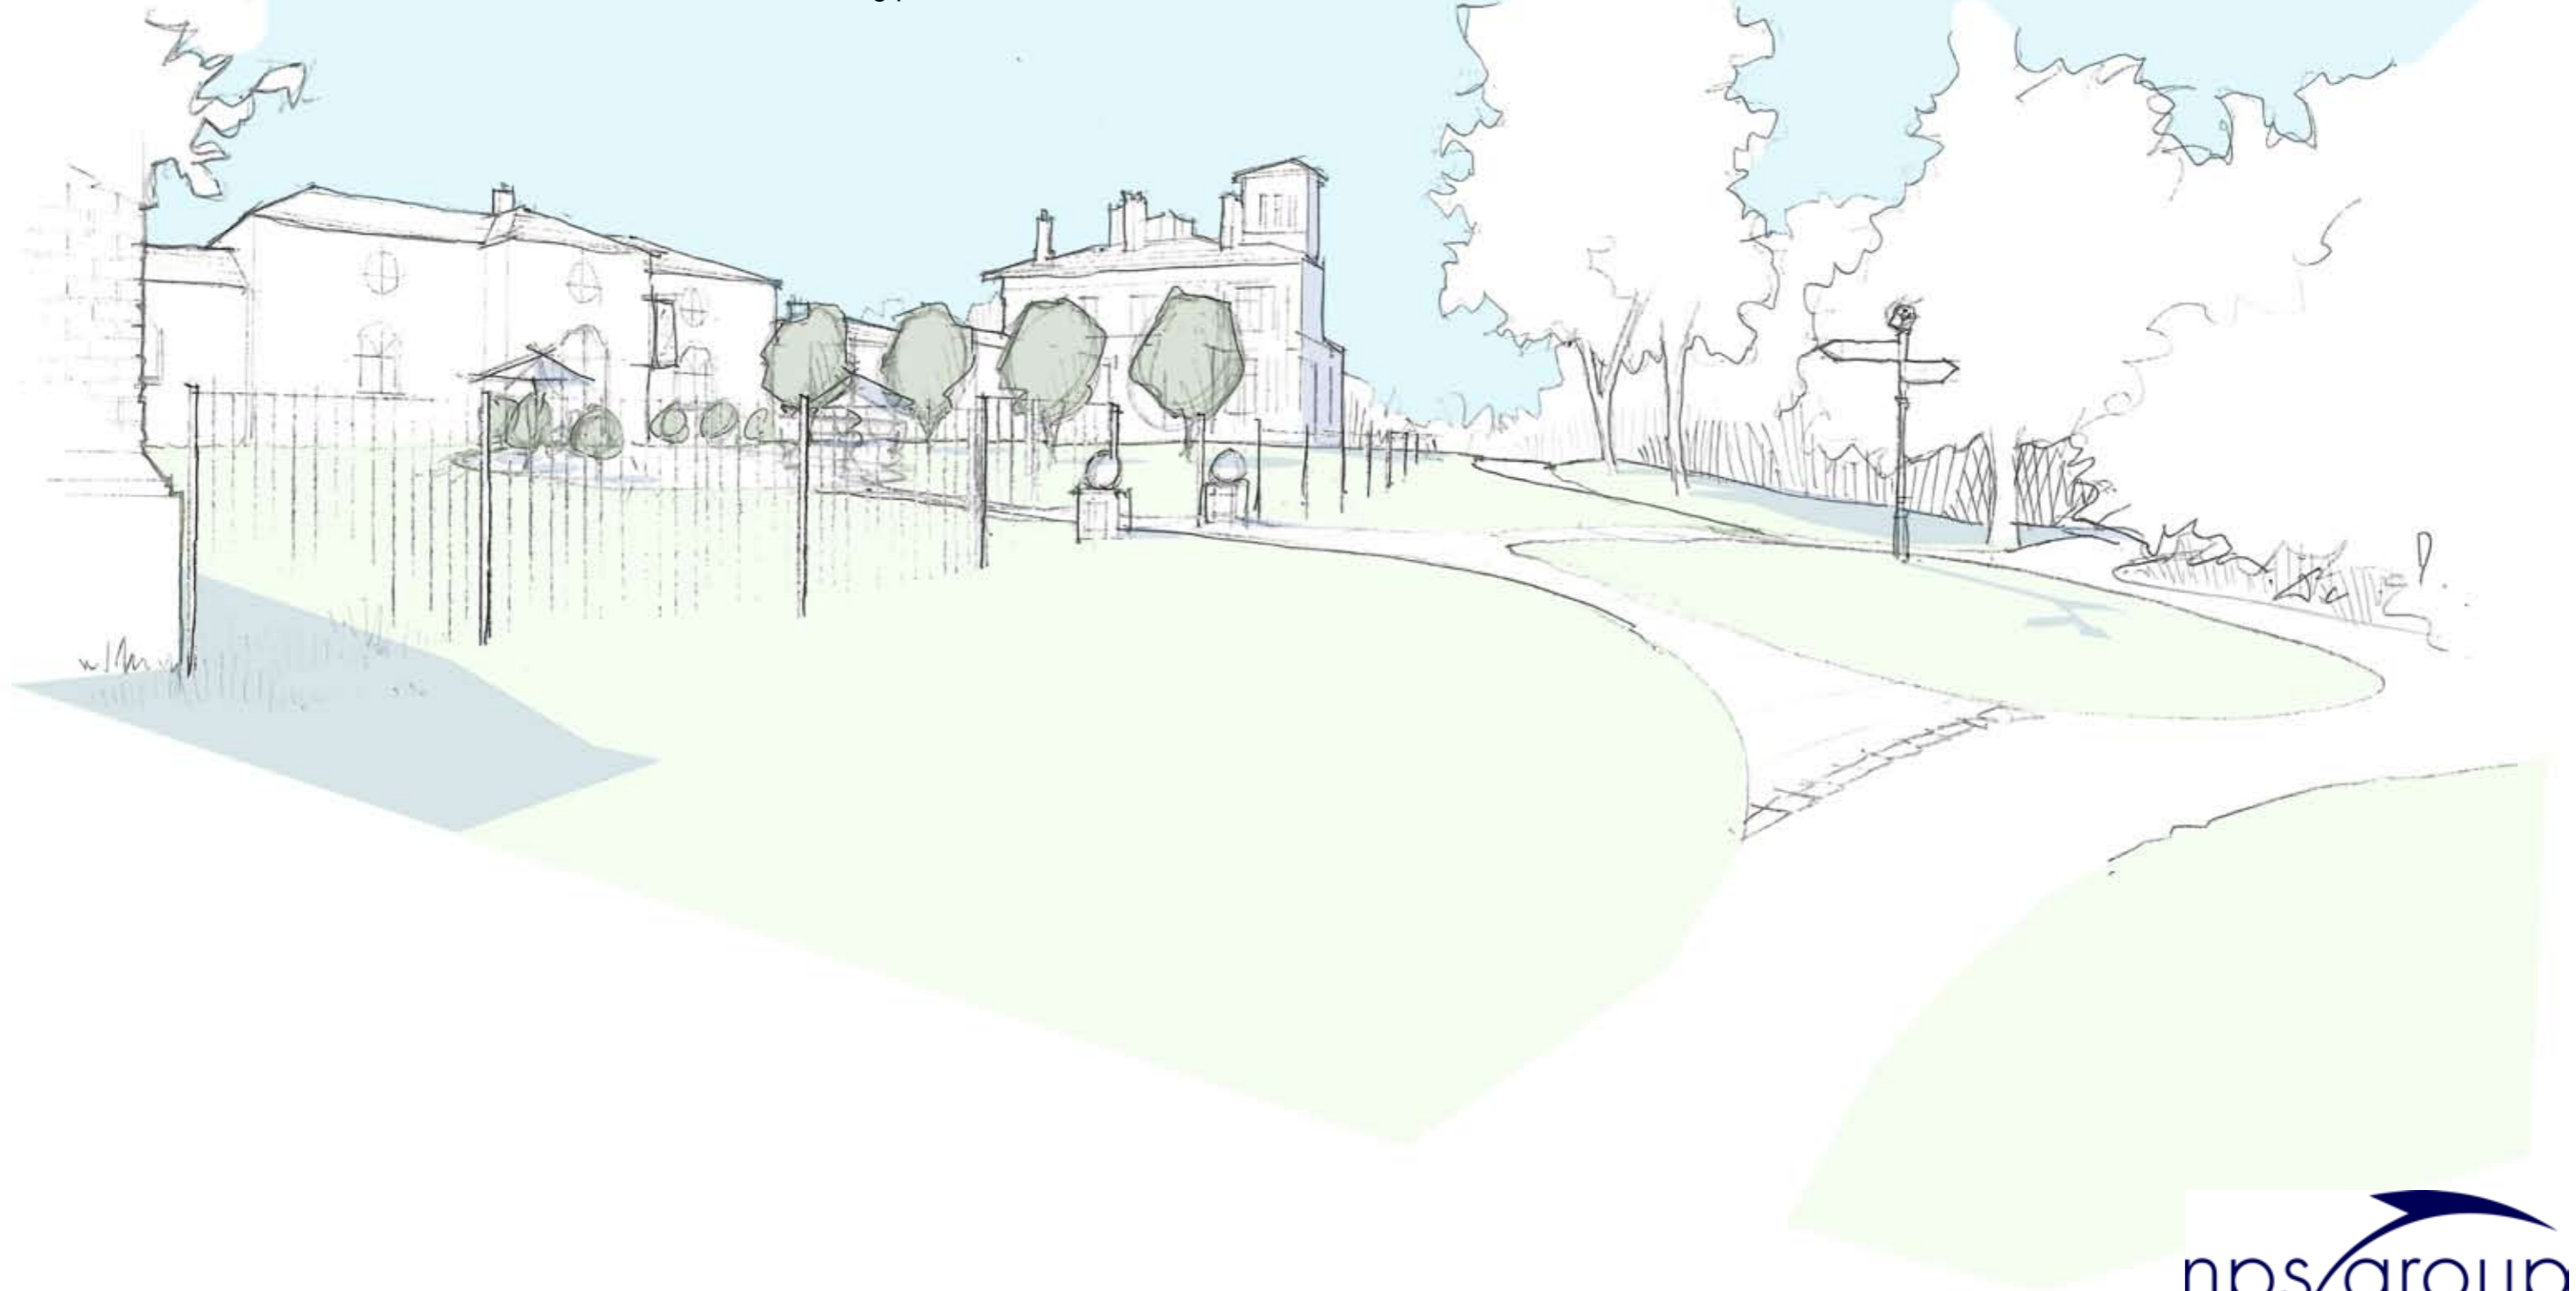
New Link between Bistro/Cafe & the Park

New outside seating area associated with the bistro and Mansion House with views over the folley & pond, A new path into the park will create the opportunity for increased physical & economic interaction between the building and the surrounding parkland.
